Visual Property Inspection Report

Complies with Australian Standard AS 4349.1-2007 & 4349.3

4 Purchase Road, Perth WA 8000

VISUAL BUILDING INSPECTION REPORT

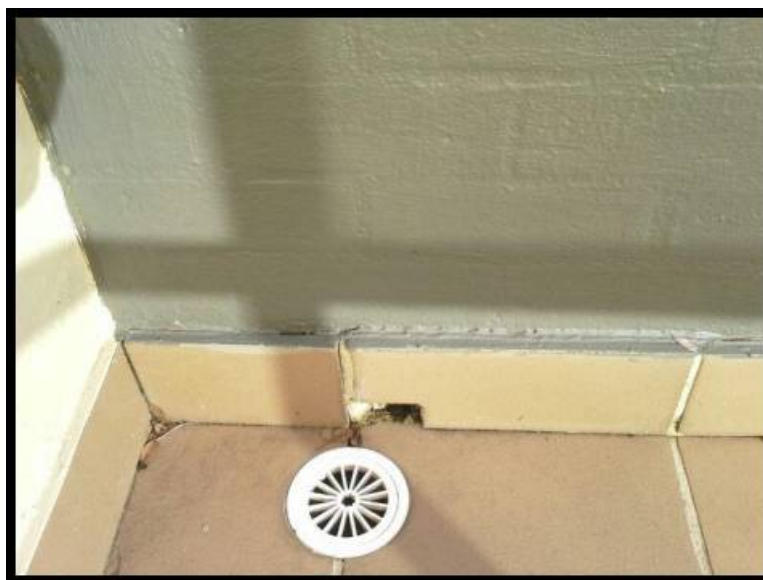
Cracked and drummy floor tiles are present and require repair or replacement. The loose hand rail requires securing and additional support. Balustrades is damaged or in poor condition and recommend replacing.

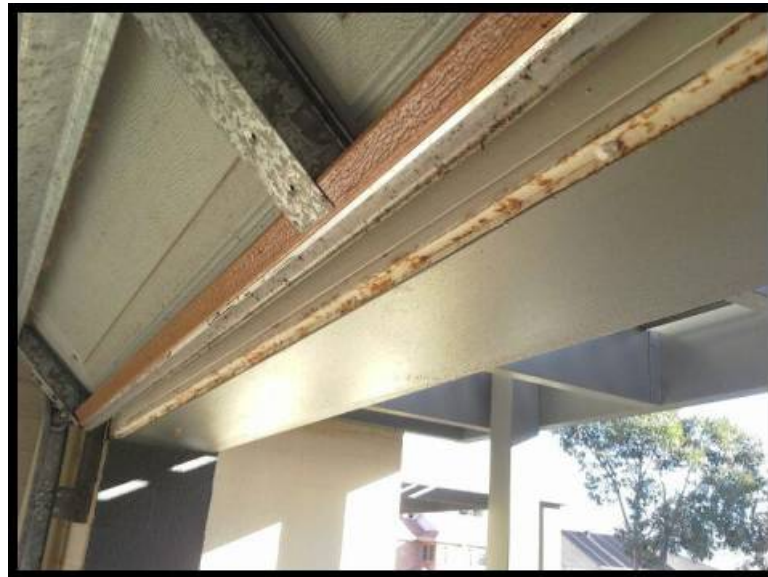
Accommodation Type:	Garage.
Location:	Under the main building.
General Condition:	The structure is generally in fair condition.
Lintels - Type & Condition:	Lintel type/s noted: Mild steel. Rust is evident to some steel lintels. Rusted areas should be treated to prevent further deterioration.

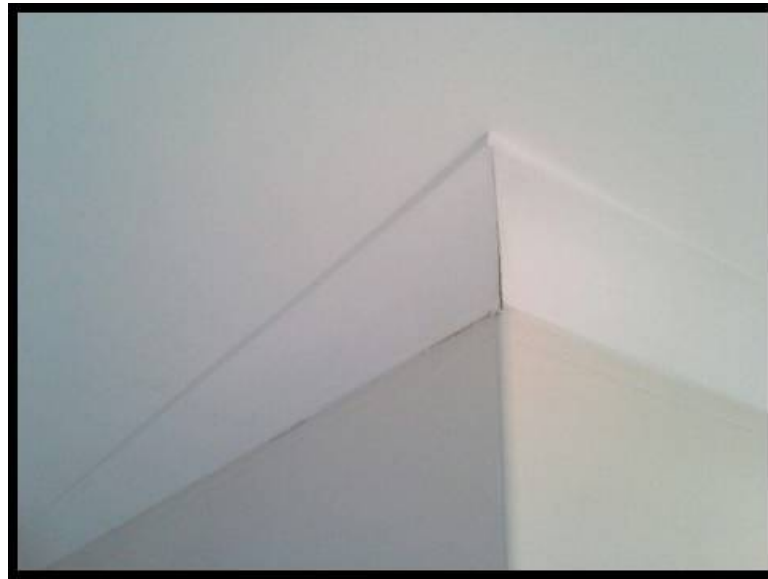
Location/Area: Isolated areas throughout. Ensuite.

The condition of the ceilings is generally fair. Cracking is present to cornices and these areas will require maintenance and or repair.

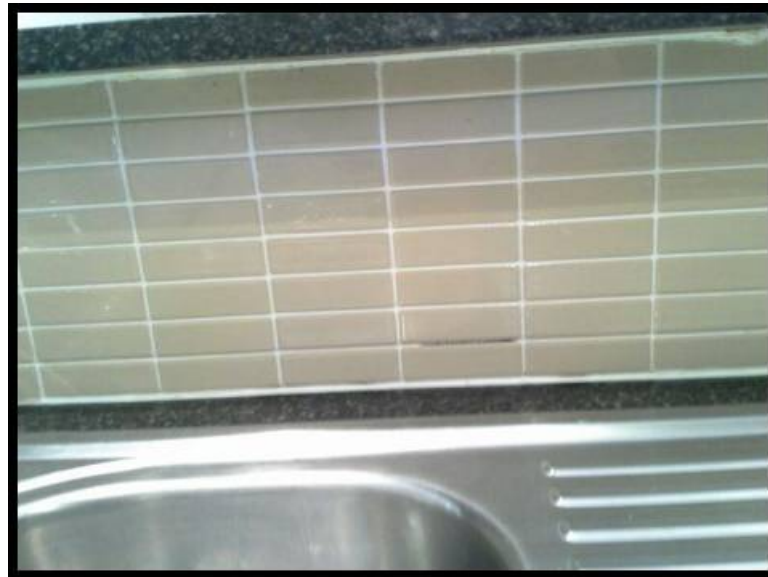
Tiles: The condition of the tiles is generally fair. Grouting requires completing to the tiled areas.

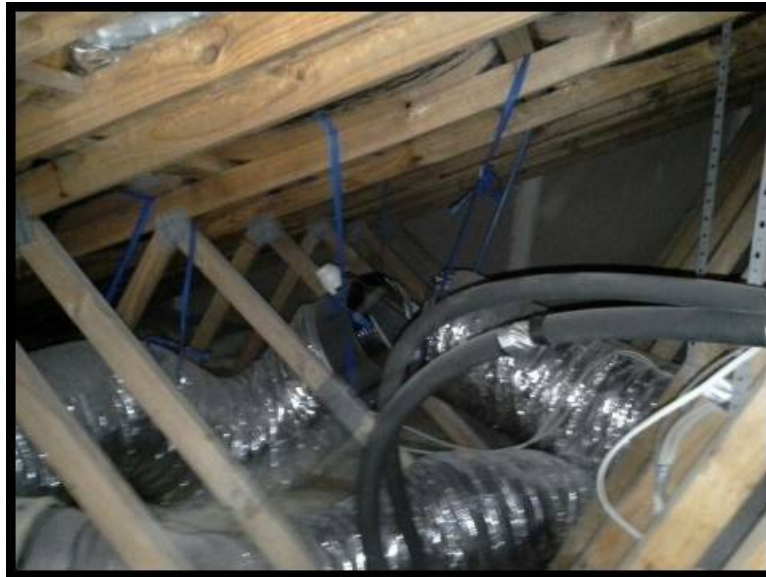
Sarking paper and insulation is present in the roof cavity. This restricted inspection to some roofing timbers. Removal of insulation is not within the scope of a standard visual building inspection report. Ducting associated with air-conditioning or heating restricted inspection. Inspection was restricted above the following locations and or areas: All internal areas.

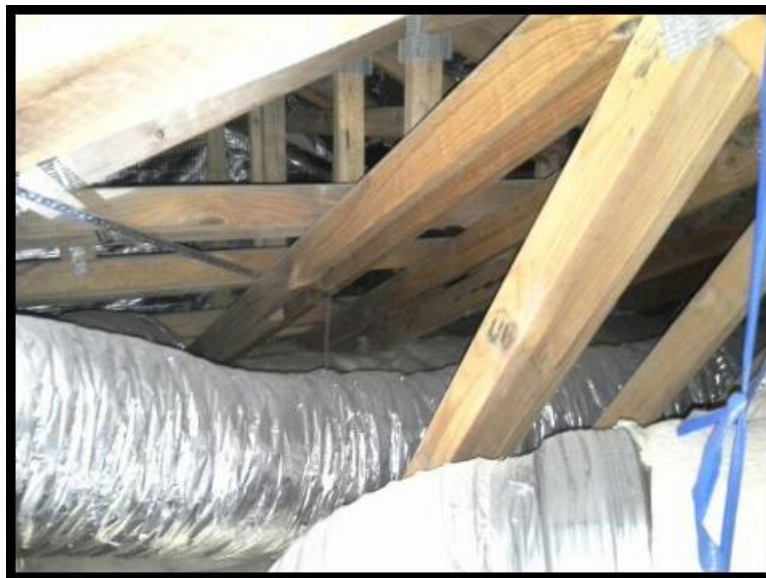
A section of the roof is of skillion type construction and there is no accessible cavity for inspection. Inspection over the eaves and low areas to the perimeter of the building was restricted due to the low pitch and method of construction allowing only a limited visual inspection from a distance. Items such as top plates and ceiling and roof framing in these areas was not able to be fully inspected. The roof is of trussed style construction and due to the nature of this construction inspection within the roof cavity was limited in some areas.

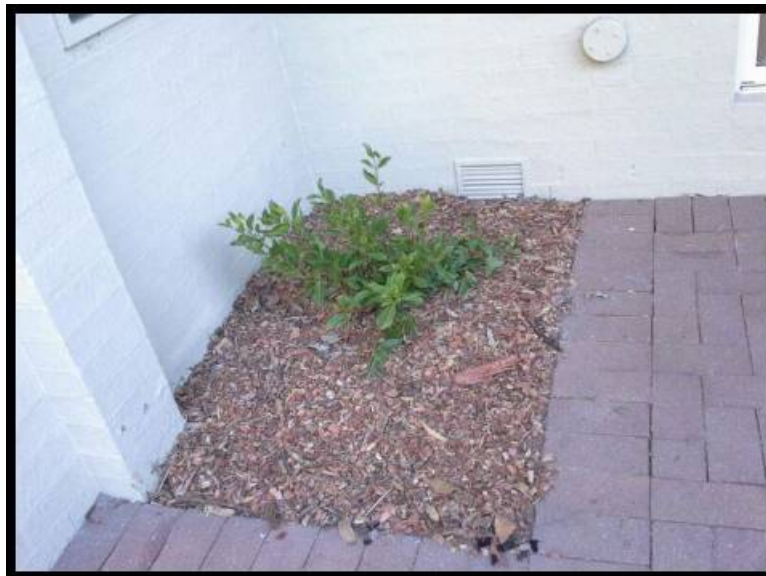
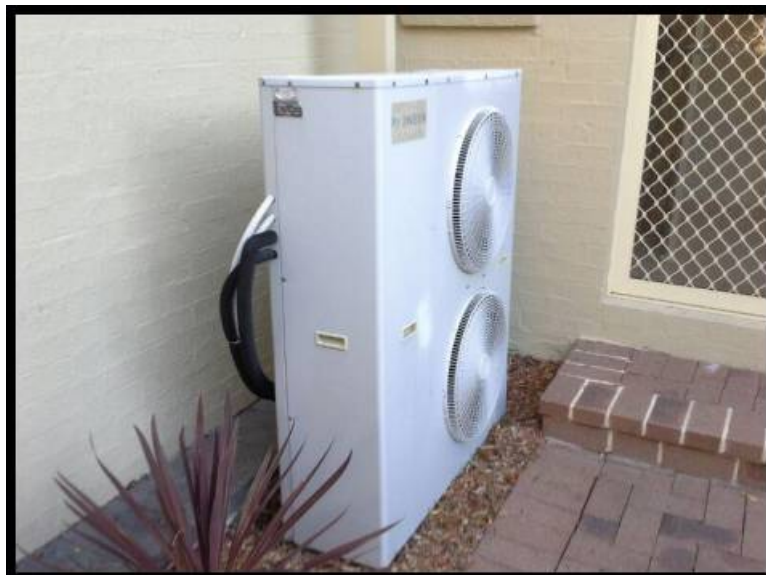
The air-conditioning condenser discharges adjacent to the external walls. We recommend modification so that water is discharged over a drain.

Gardens or soil have been built up against the base of fences in some areas. This build up can conceal current timber pest attack and significantly increases the risk of future attack. Gardens and soil should not be built up against fencing timbers and we recommend modifications be made.

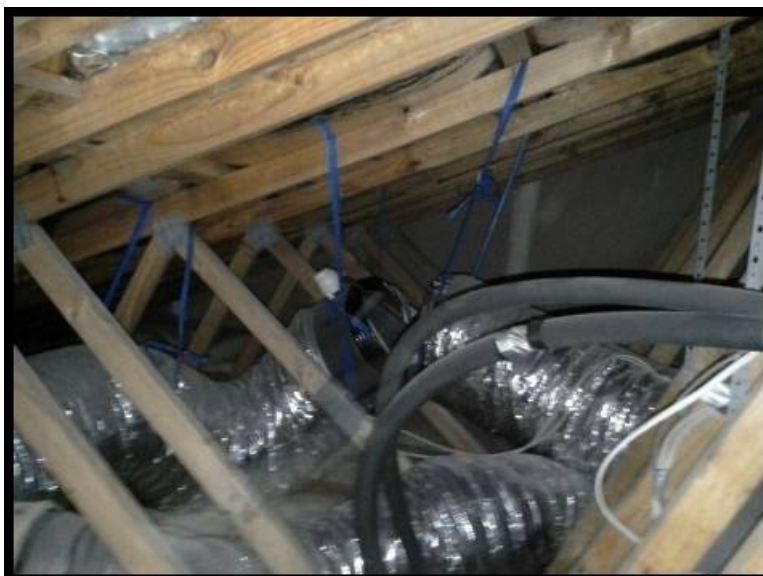
Sarking paper and insulation is present in the roof cavity. This restricted inspection to some roofing timbers. Removal of insulation is not within the scope of a standard visual building inspection report. Ducting associated with air-conditioning or heating restricted inspection. Inspection was restricted above the following locations and or areas: All internal areas.

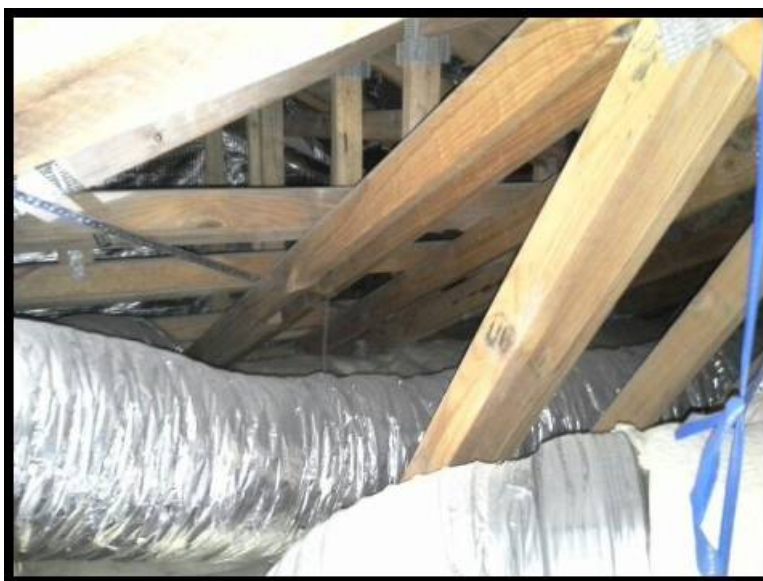
A section of the roof is of skillion type construction and there is no accessible cavity for inspection. Inspection over the eaves and low areas to the perimeter of the building was restricted due to the low pitch and method of construction allowing only a limited visual inspection from a distance. Items such as top plates and ceiling and roof framing in these areas was not able to be fully inspected. The roof is of trussed style construction and due to the nature of this construction inspection within the roof cavity was limited in some areas.
