## Visual Property Inspection Report

Complies with Australian Standard AS 4349.1-2007

## VISUAL BUILDING INSPECTION REPORT

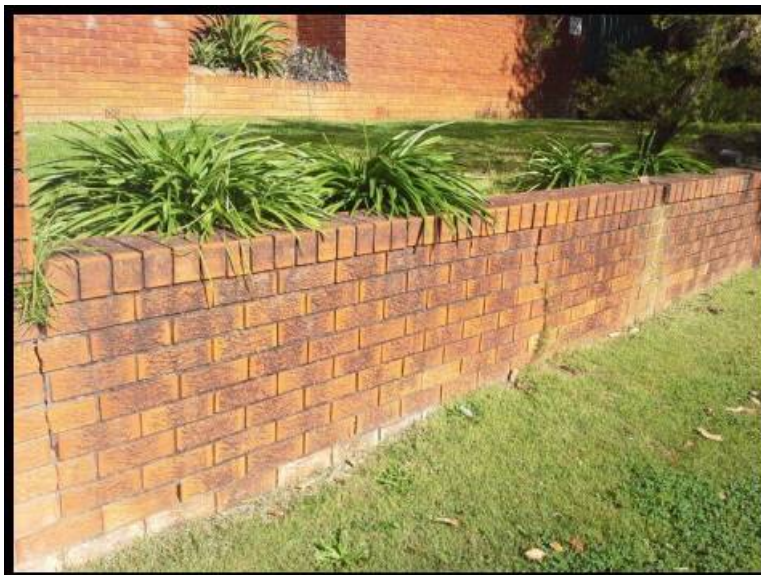
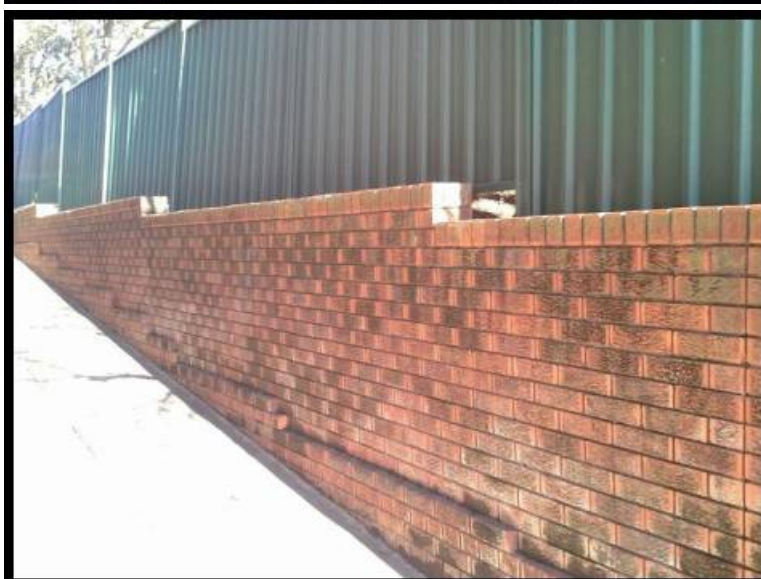
Western elevation. Front elevation.

replaced. The retaining wall appears to be under designed. This is not a qualified engineer's opinion and we recommend that you seek advice from Structural or Geotechnical Engineer.

The masonry retaining wall is leaning and should be monitored for additional movement. A suitably qualified Structural or Geotechnical Engineer should investigate condition of the retaining wall.

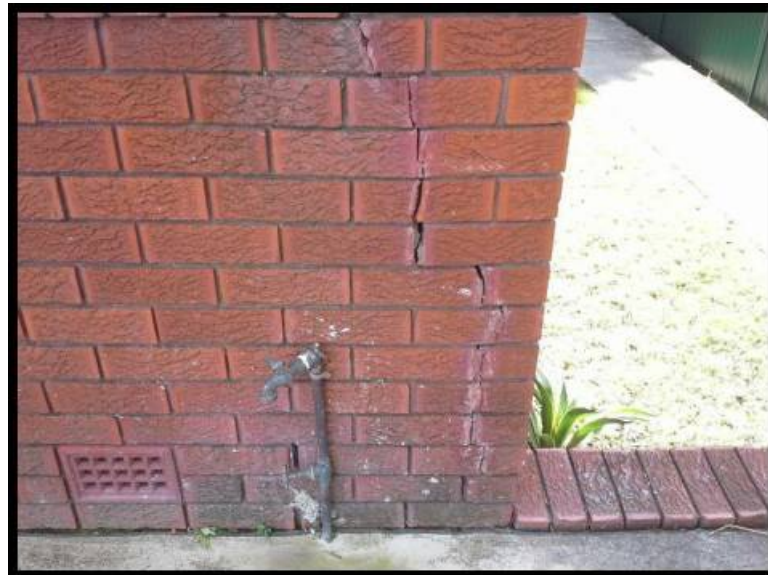
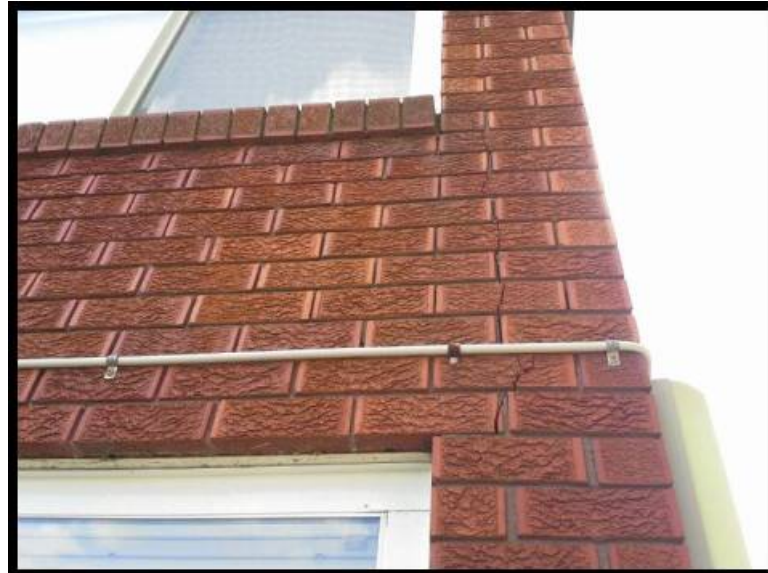
Western elevation. Rear elevation.

Cracks are evident to masonry. Visible cracking appears major and a Structural Engineers opinion should be sought. Please refer to section of this report - CRACKING OF BUILDING ELEMENTS for additional details.

Cracks are evident to brickwork. Visible cracking appears major as they are in a structural component of the building. Cracking appears to be brick growth and is common in brick buildings that have long runs of brick walls without control joints. A Structural Engineers opinion should be sought on how to repair these damaged areas. Please refer to section of this report - CRACKING OF BUILDING ELEMENTS for additional details.

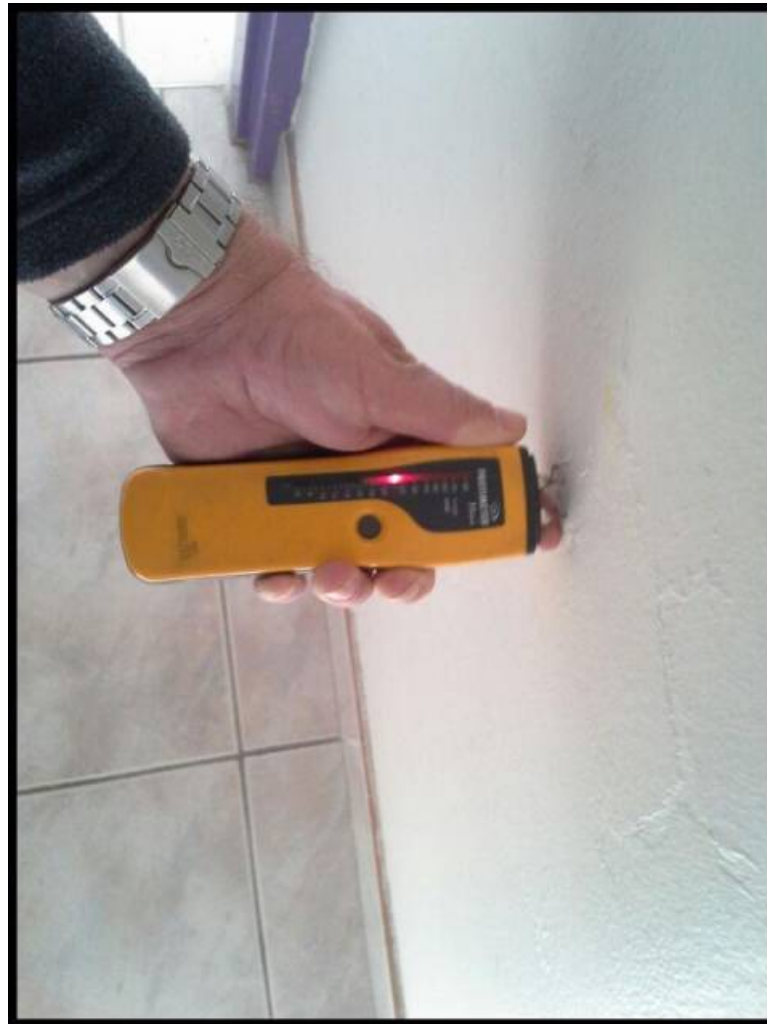
**Location/Area:** Bedroom two. Hallway.  
Estimate cost from: Not available (Quotations should be commissioned)

Lateral dampness was detected in the wall backing onto the bathroom. This could be the result of a plumbing leak or leaking bathroom fixture and should be further investigated.
