Visual Defects (Handover) Property Inspection Report

1 Purchase Road, Best Home

VISUAL BUILDING INSPECTION REPORT

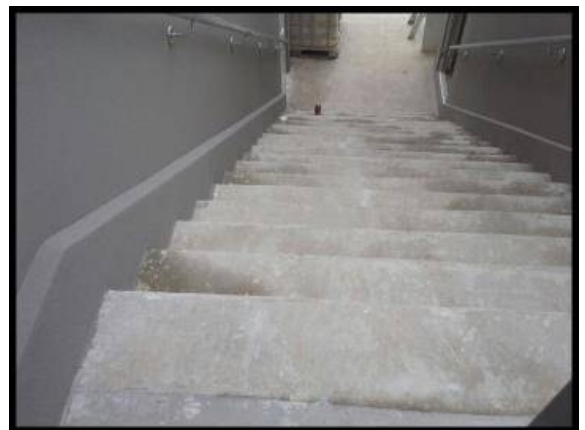
The stairs are constructed primarily from concrete. The condition of the stairs are generally acceptable. A full builders final clean including, cleaning, removal of trade marks, scuffs and touchup of paintwork is required to provide an acceptable finish to this area.

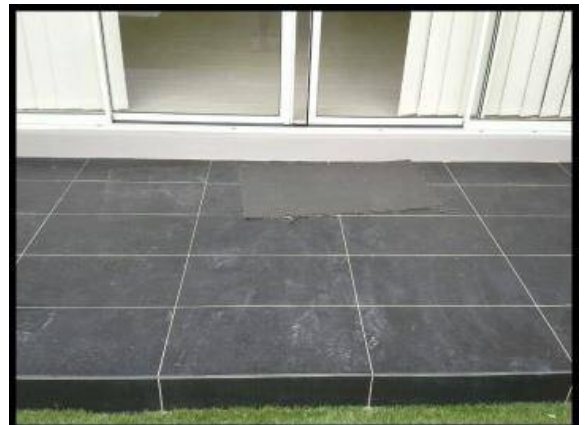
Marks and dirt are evident to the tiled areas. These areas will require cleaning. Rectification will be required. Minor paint touch required around door frame. Rectification will be required.

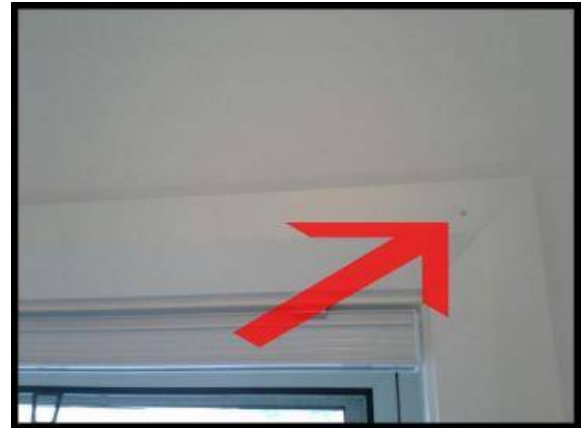
Woodwork: Minor damage noted requiring paint repair. Rectification will be required.

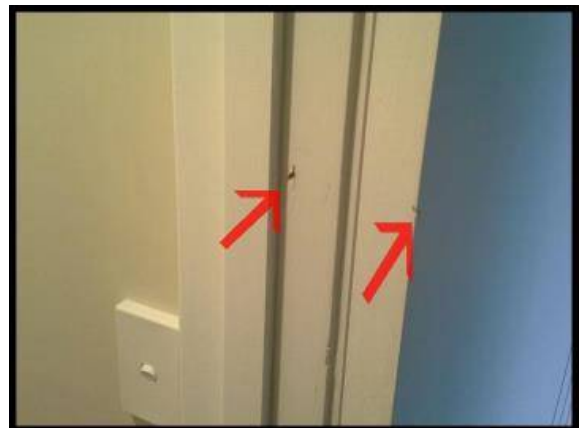
Door jamb/s are damaged and these areas will require maintenance, repair or replacement. Minor damage noted requiring paint repair. Rectification will be required.
