## Visual Timber Pest Inspection Report

25 Purchase Road, Dural

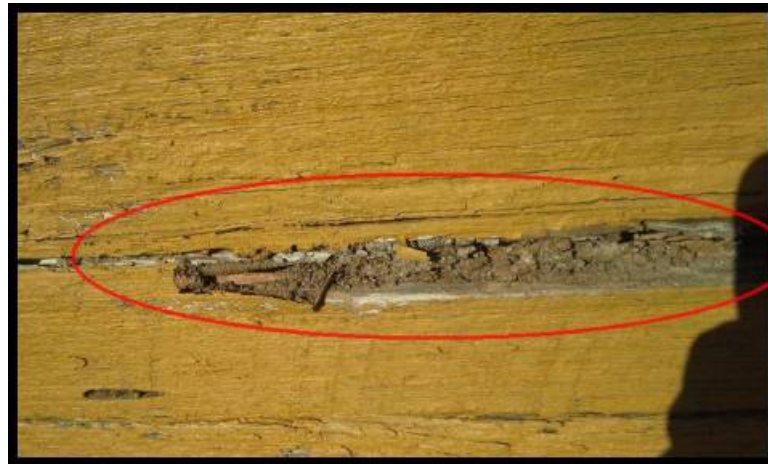
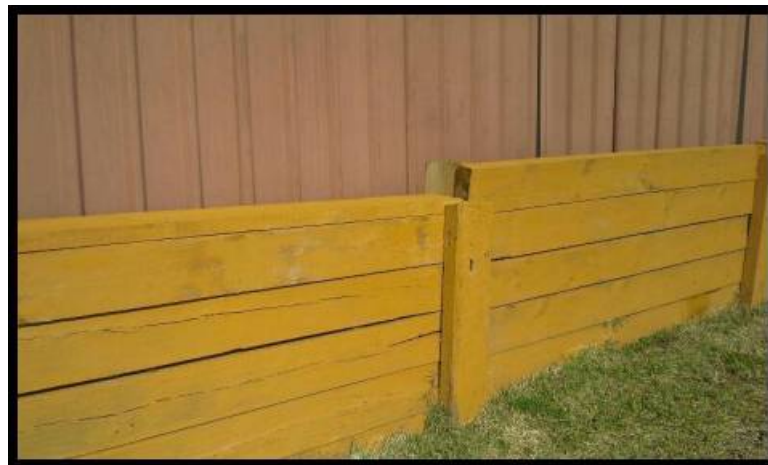
**Affected External Timbers** Sleepers or timber landscaping materials:

**Severity:** Visible timber damage appears moderate. Please refer to the building report for details or if a building inspection was not commissioned we recommend a builder inspection and report on the property. Refer to the definitions section of this report - TERMS & LIMITATIONS - Timber Damage.

**Location/Area** Western elevation.

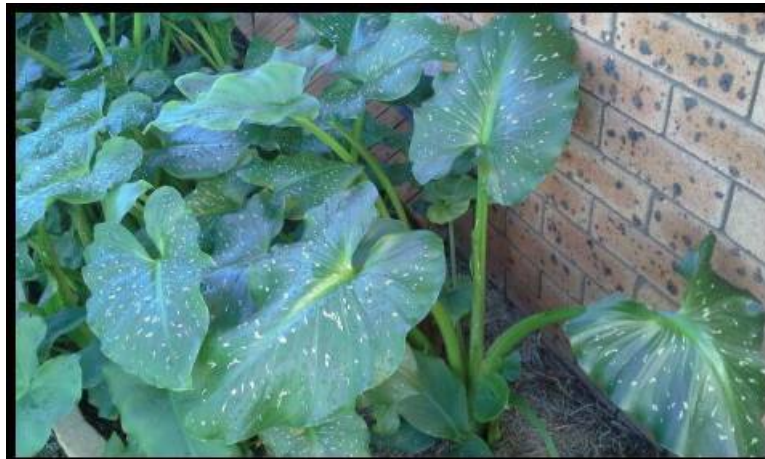
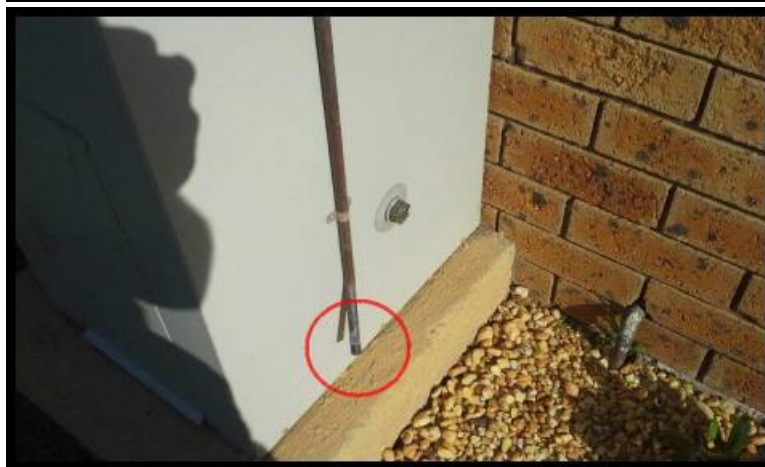
**Description** The air-conditioning condenser discharges adjacent to the external walls. We recommend modification so that water is discharged over a drain. We recommend the test drilling of trees or tree stumps on the property as they are capable of concealing termite colonies. The external vents/weep holes are either covered completely or partly concealed. This can allow concealed termite entry and we recommend that all vents/weep holes be exposed and kept clear of soil, foliage, debris, stored items or other obstructions. The level of some external paths, paved areas or soil is either higher than, or at a similar level, as that of the internal floors. This situation could allow concealed termite entry. We strongly recommend the lowering of these to below the internal floor level to reduce the risk of concealed termite entry. The hot water system overflow is discharging moisture adjacent to the structure. We recommend the overflow be situated over a drain. Untreated landscaping timbers should be removed or replaced with a treated timber or non timber alternative. If replaced with timber, ensure appropriate durability rating for external use. Water is ponding on the soil adjacent to the building structure. This may be due to a drainage problem or some other factor. This should be rectified as moist soil conditions are highly conducive to timber pest attack. Garden beds have been built up against the external walls. These should be removed as they can allow concealed termite entry.

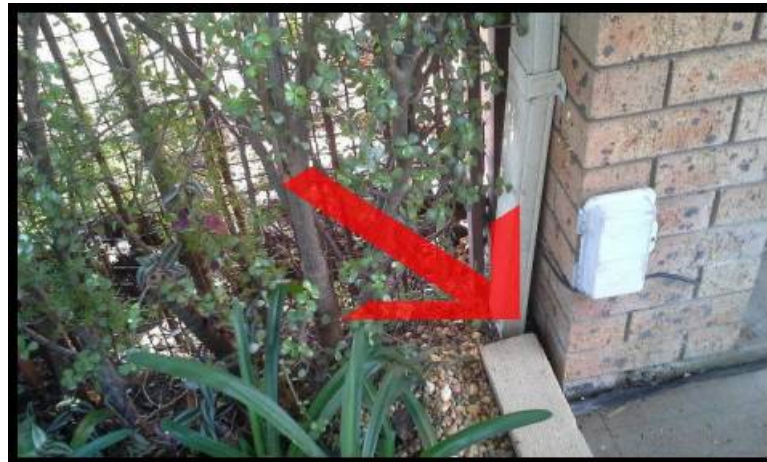
**Description** Garden beds have been built up against the external walls. These should be removed as they can allow concealed termite entry.

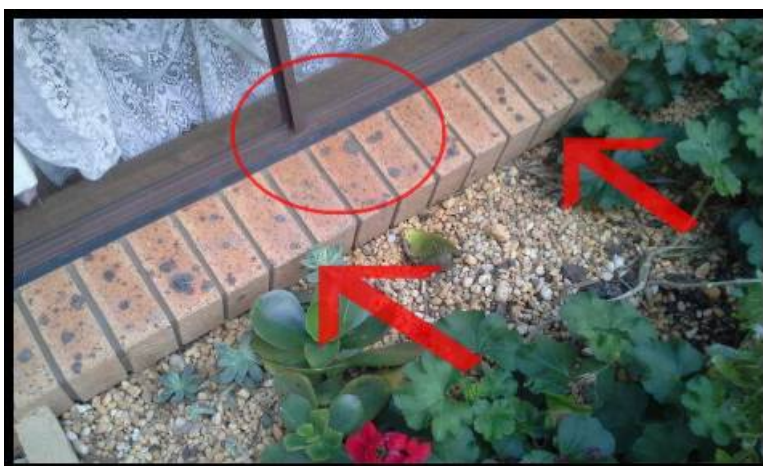
The property is constructed on a concrete slab foundation to which there is no subfloor for inspection. See important information in Section 4.0 Concrete Slab Homes (Part or Full Slab). Inspection of the concrete floor slab edge was restricted. In our experience, termites most commonly enter over the slab edge and therefore we recommend modifications be made by lowering all grounds levels to expose the concrete slab edge as this is an undetected entry point for timber pest attack, see Section 4.0 - Concrete Slab Homes (part or full). The following items restricted access to the edge of the slab; Soil. Paths. Patios. Gardens. Gravel. Brickwork. Timbers. Hot water service.

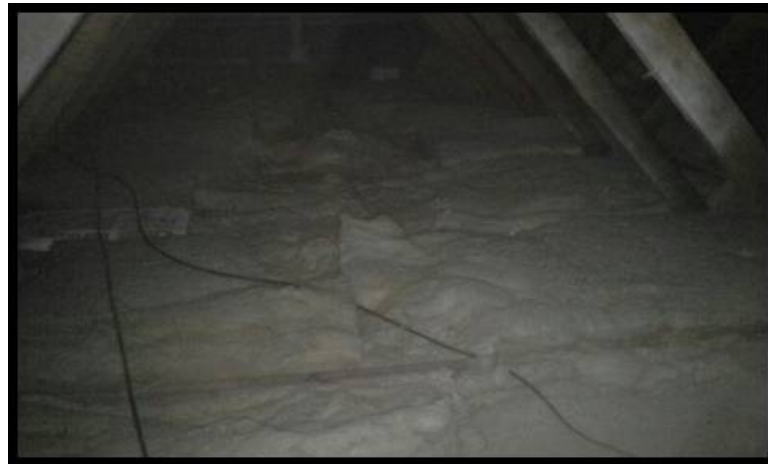
Insulation is present in the roof cavity. This restricted inspection to some roofing timbers. Removal of insulation is not within the scope of a standard visual inspection report.

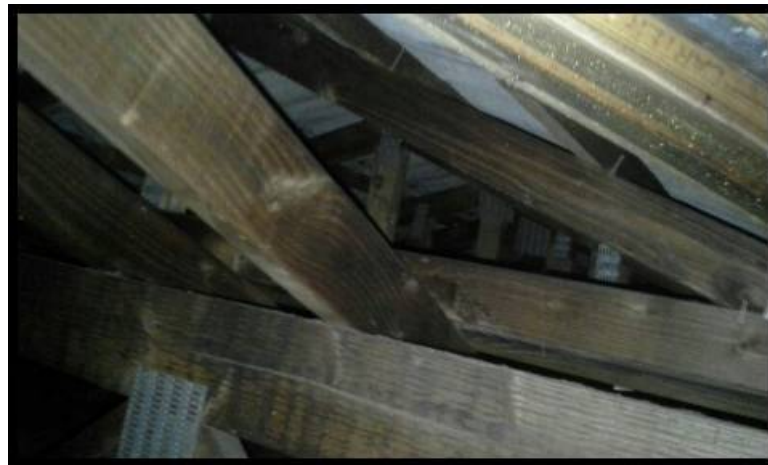
Inspection over the eaves was restricted due to the low pitch and construction allowing only a limited visual inspection. The roof is of trussed style construction and due to the nature of this construction inspection within the roof cavity was limited in some areas. Inspection was restricted above the following locations and or areas: Ensuite. Main bedroom. Entry/Foyer. Hallway.
