Visual Property Inspection Report

Complies with Australian Standard AS 4349.1-2007 & 4349.3

4 Purchase Road, Perth WA 8000

VISUAL BUILDING INSPECTION REPORT

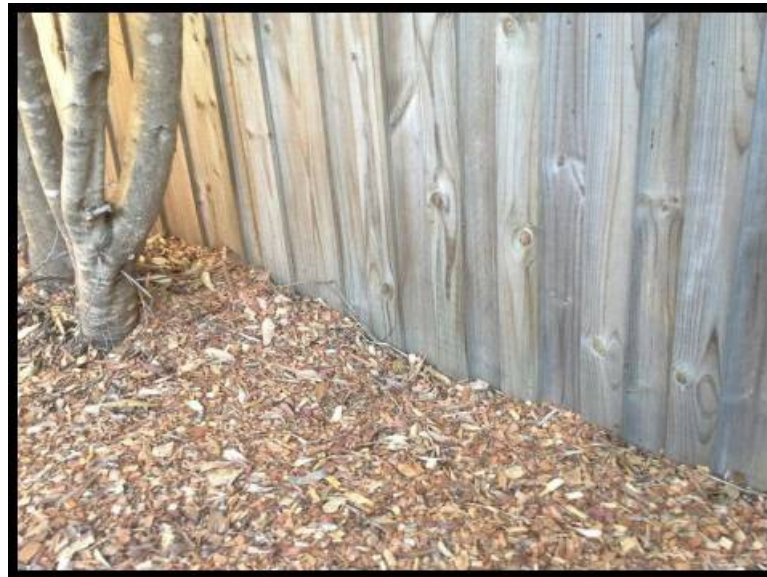
The air-conditioning condenser discharges adjacent to the external walls. We recommend modification so that water is discharged over a drain.

Gardens or soil have been built up against the base of fences in some areas. This build up can conceal current timber pest attack and significantly increases the risk of future attack. Gardens and soil should not be built up against fencing timbers and we recommend modifications be made.

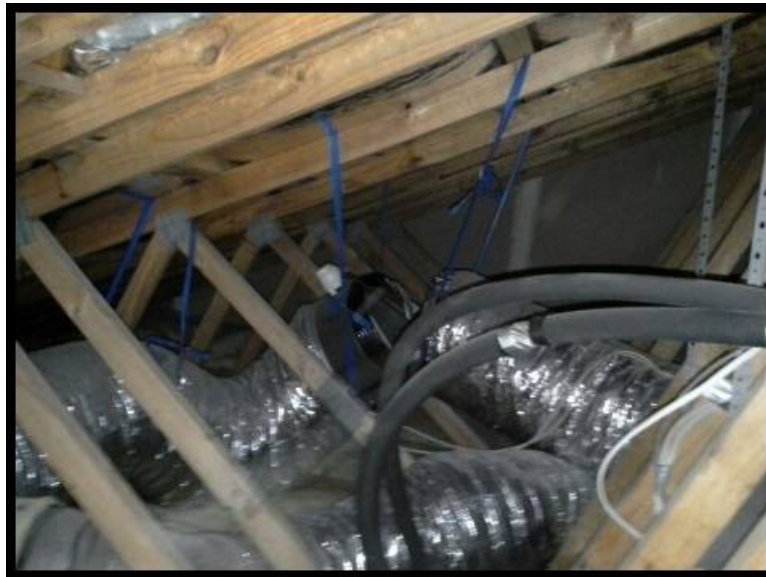
Sarking paper and insulation is present in the roof cavity. This restricted inspection to some roofing timbers. Removal of insulation is not within the scope of a standard visual building inspection report. Ducting associated with air-conditioning or heating restricted inspection. Inspection was restricted above the following locations and or areas: All internal areas.

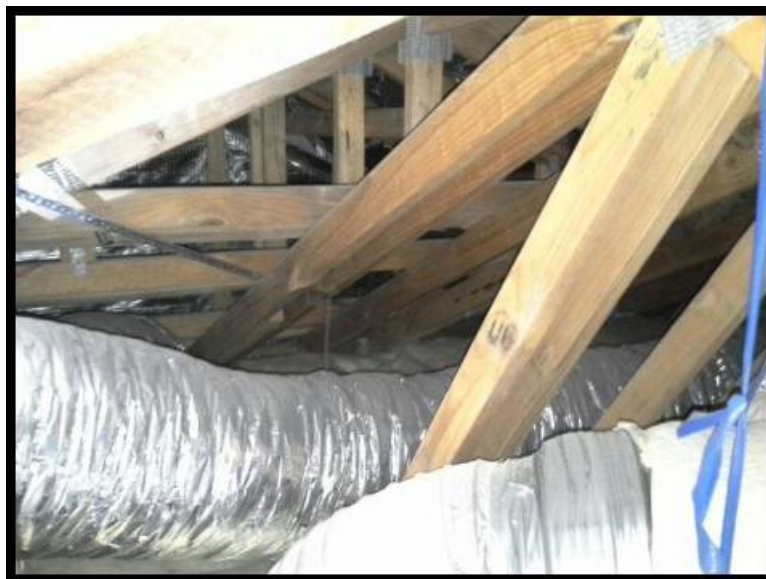
A section of the roof is of skillion type construction and there is no accessible cavity for inspection. Inspection over the eaves and low areas to the perimeter of the building was restricted due to the low pitch and method of construction allowing only a limited visual inspection from a distance. Items such as top plates and ceiling and roof framing in these areas was not able to be fully inspected. The roof is of trussed style construction and due to the nature of this construction inspection within the roof cavity was limited in some areas.
