## Visual Property Inspection Report

Complies with Australian Standard AS 4349.1-2007

**2 Purchase Road, Sydney QLD 7000**

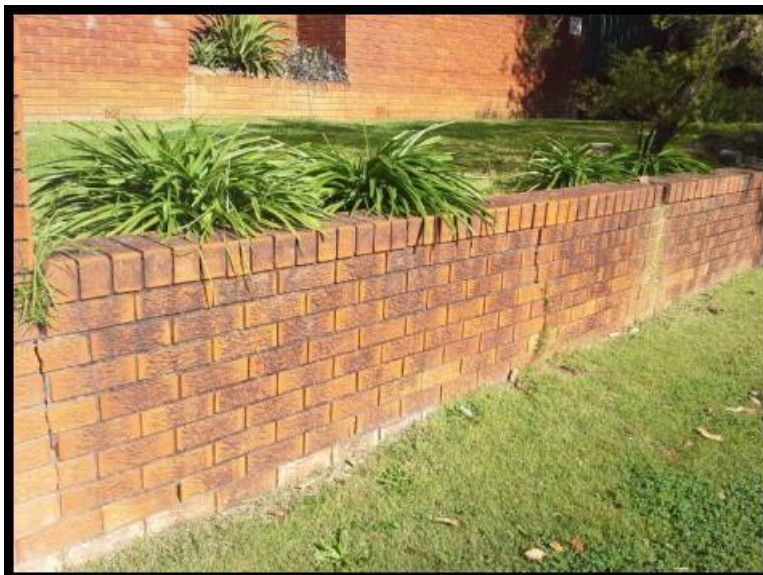
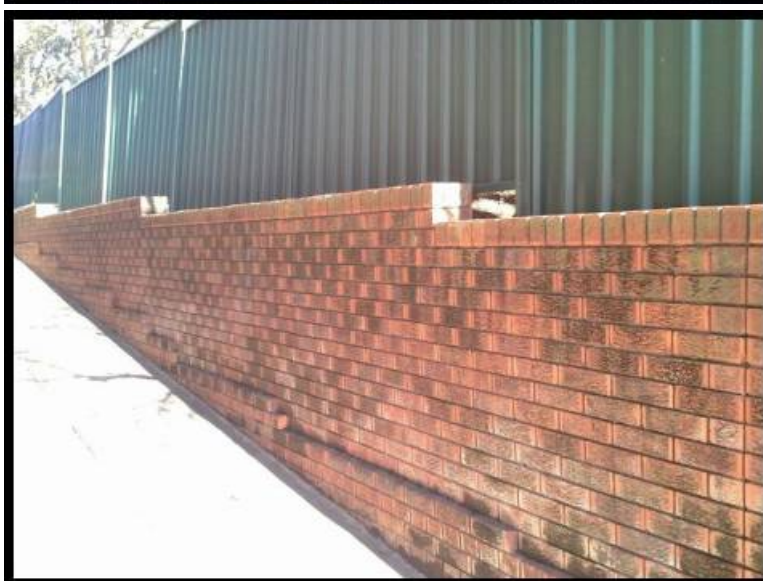
Western elevation. Front elevation.

<b>Type &amp; Condition:</b>	The masonry retaining walls are in poor condition and should be repaired or
------------------------------	---

replaced. The retaining wall appears to be under designed. This is not a qualified engineer's opinion and we recommend that you seek advice from Structural or Geotechnical Engineer.

The masonry retaining wall is leaning and should be monitored for additional movement. A suitably qualified Structural or Geotechnical Engineer should investigate condition of the retaining wall.

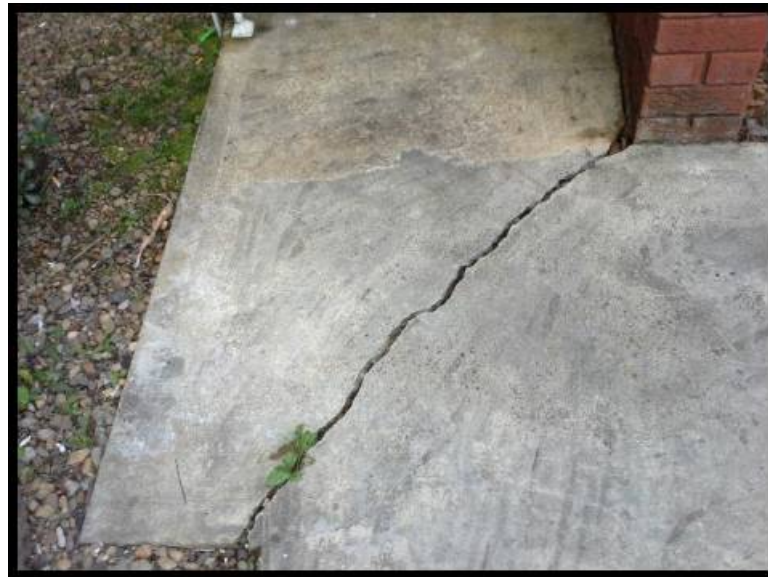
The paths have some visible cracking and damaged areas require repair and or replacement.

The paths have subsided in areas and will require repair and or relaying.

**Structural Defect Cracking:** Located: Pathways Width: 10mm Length: Various.

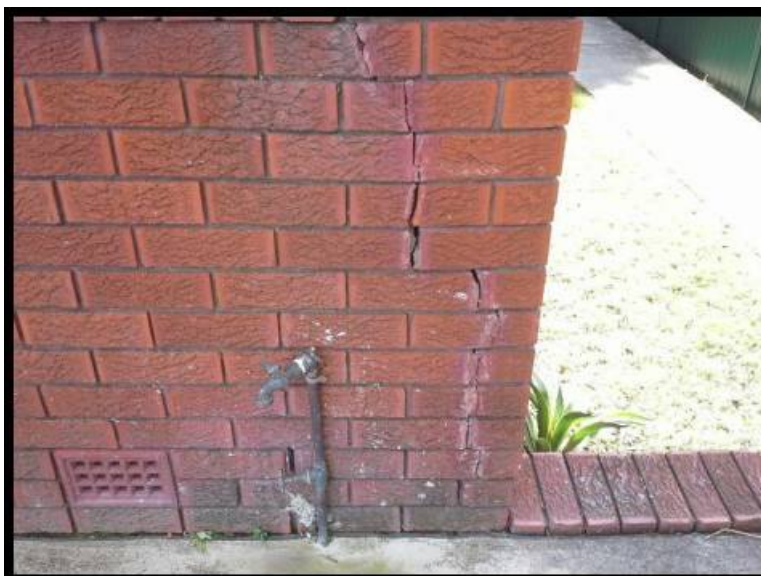
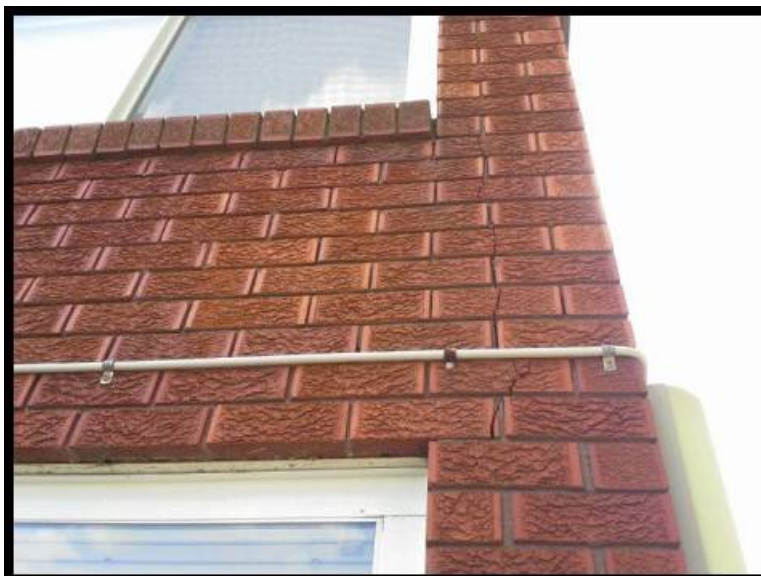
Western elevation. Rear elevation.

Cracks are evident to masonry. Visible cracking appears major and a Structural Engineers opinion should be sought. Please refer to section of this report - CRACKING OF BUILDING ELEMENTS for additional details.

Cracks are evident to brickwork. Visible cracking appears major as they are in a structural component of the building. Cracking appears to be brick growth and is common in brick buildings that have long runs of brick walls without control joints. A Structural Engineers opinion should be sought on how to repair these damaged areas. Please refer to section of this report - CRACKING OF BUILDING ELEMENTS for additional details.

**Type & Condition:** The building is constructed on a combination of strip footings, piers and concrete slab. Structural cracking to external walls is evidence of subsidence to the footings. This defect should be referred to a Structural or Geotechnical Engineer for further evaluation.

**Structural Defect Cracking:** Located: Various South elevation West elevation Width: 1-3mm 5mm Length: Various.

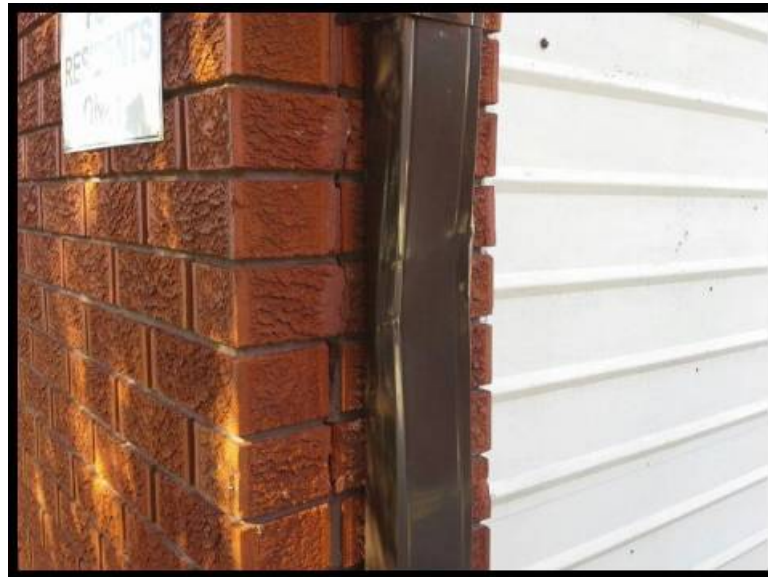
**Gutter & Downpipes Condition:** Due to access limitations the guttering and associated areas were not inspected. Defects may be present and not detected. Downpipes are damaged or rusting and should be repaired or replaced as necessary. Downpipes appear to be connected to the stormwater dispersal system, however, correct connection can only be confirmed with a smoke test.

Estimated cost from: \$1200.

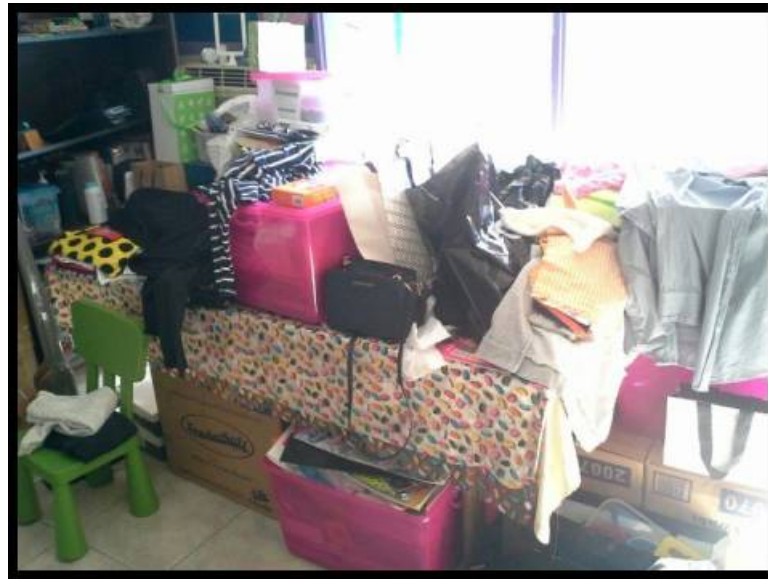
**Restrictions:** A significant amount of stored goods were present to the area(s) listed below which restricted the inspection. Stored items should be removed to allow a more complete inspection to be carried out. Access was limited in the following locations and or areas: All internal areas.

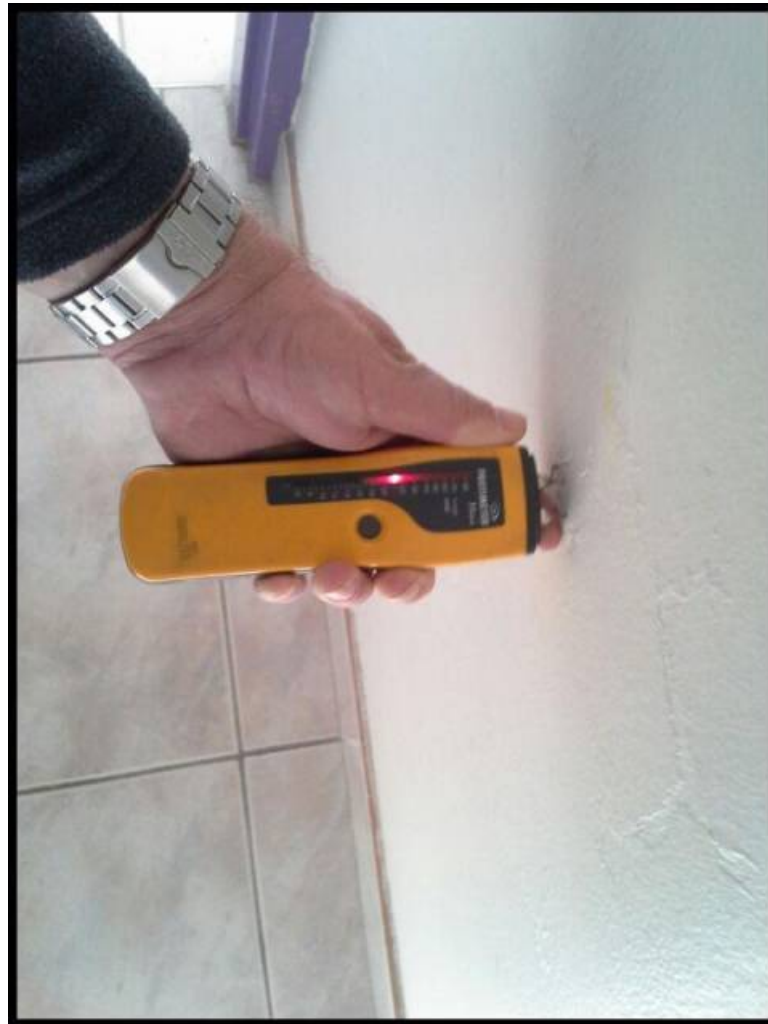
**Location/Area:** Bedroom two. Hallway.  
Estimate cost from: Not available (Quotations should be commissioned)

Lateral dampness was detected in the wall backing onto the bathroom. This could be the result of a plumbing leak or leaking bathroom fixture and should be further investigated.

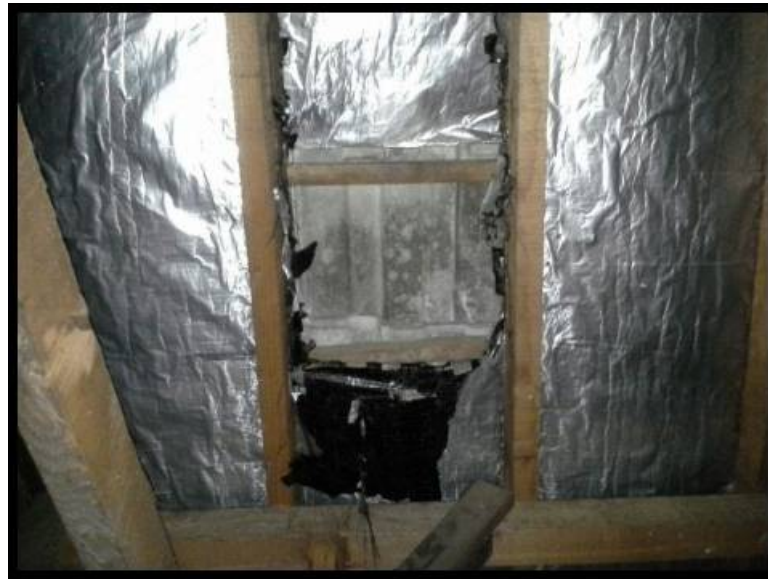
**Sarking Status:** Sarking is present but is torn or has holes in some areas. This may affect the waterproofing ability of the sarking and damaged areas should be considered for repair.

Estimated cost from: \$350.
