## Visual Defects (Handover) Property Inspection Report

**1 Purchase Road, Best Home**

## VISUAL BUILDING INSPECTION REPORT

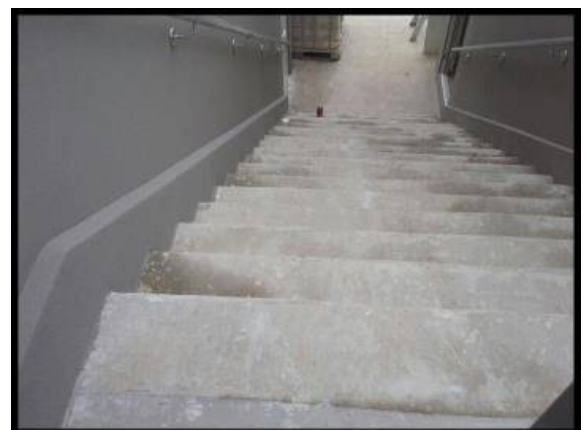
The stairs are constructed primarily from concrete. The condition of the stairs are generally acceptable. A full builders final clean including, cleaning, removal of trade marks, scuffs and touchup of paintwork is required to provide an acceptable finish to this area.

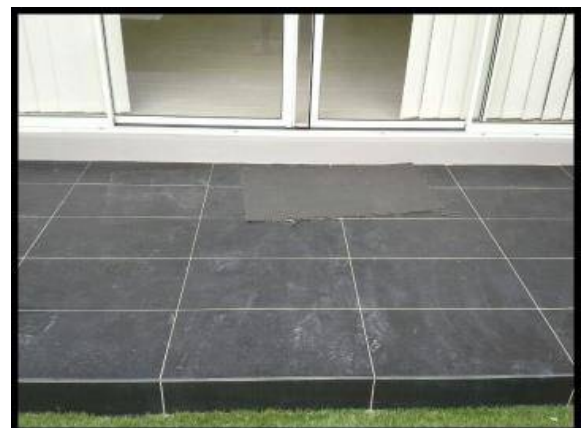
Marks and dirt are evident to the tiled areas. These areas will require cleaning. Rectification will be required. Minor paint touch required around door frame. Rectification will be required.

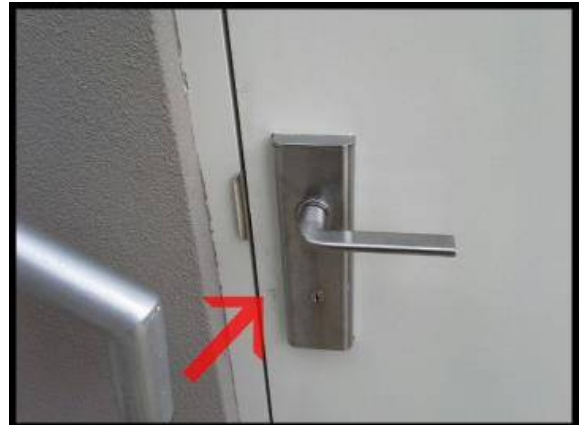
**External Door Condition:** Impact damage was noted to external door. Rectification will be required.

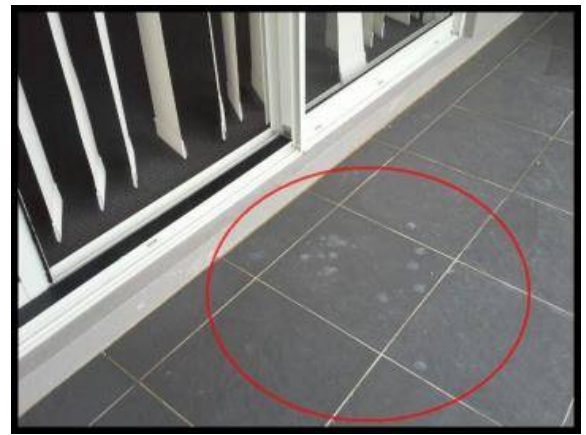
<b>Restrictions:</b>	Floorcoverings were present and restricted inspection to the upperside of flooring. A full builders final clean including, vacuuming, cleaning, removal of skuffs and marks and touchup of paintwork is required to provide an acceptable finish to the internal and external area.
----------------------	---

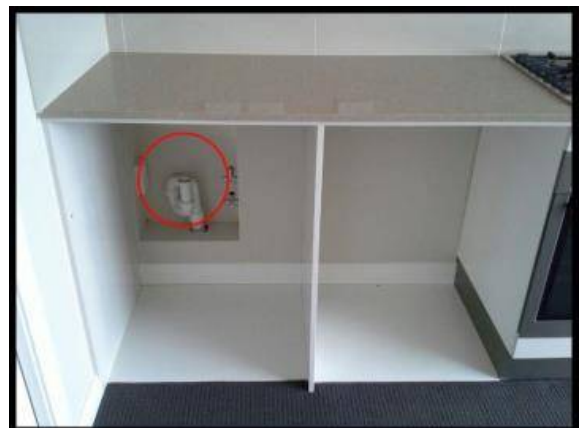
**Tub & Taps:** A laundry tub is not provided to the laundry area and is a contravention of the Standards. Recommend a wash tub be provided. Rectification will be required.  
**Tiles:** The condition of the tiles is generally acceptable.  
**Floor/Floor Waste:** There is no visible floor waste and no way for any overflow of water to escape. In the case of an overflow water may enter areas adjacent and cause a safety hazard or damage. Recommend a floor waste be installed or a fall be provided to the external of the building. Rectification will be required.

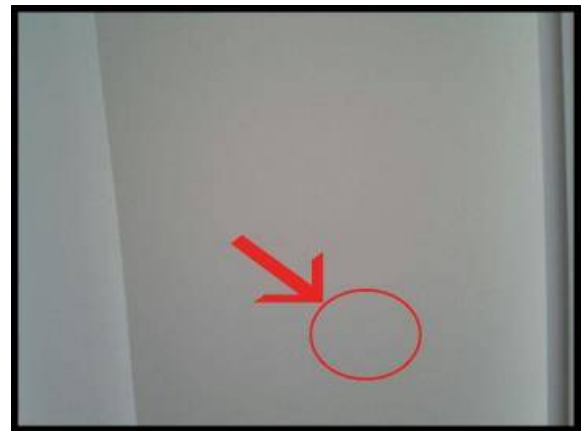
- Room Location:** Adjacent to the kitchen.
- Internal Walls Condition:** Painting is not complete, appears transparent and requires rectification to provide a suitable finish. Rectification will be required.

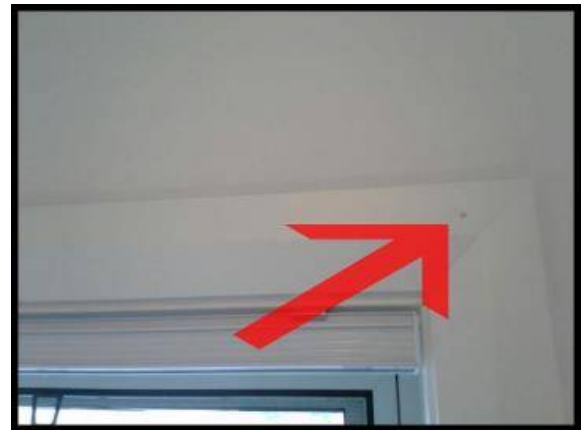
**Woodwork:** Minor damage noted requiring paint repair. Rectification will be required.

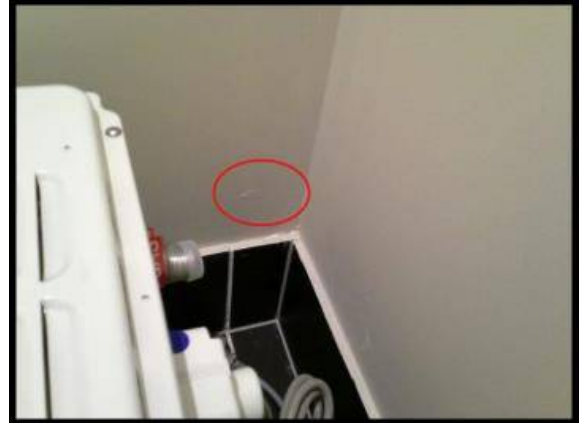
Poorly finished surfaces were noted to some sections of the wall materials and repairs are required prior to repainting. Rectification will be required.

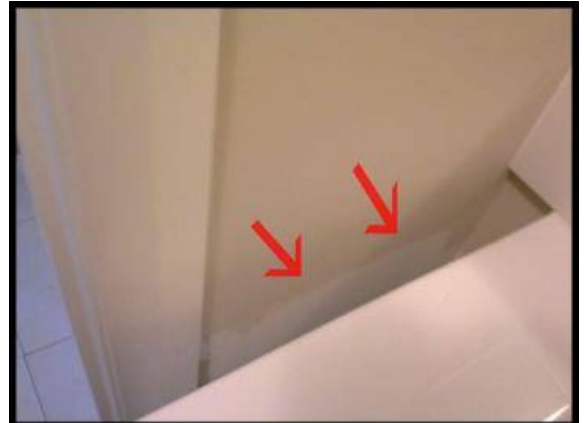
Painting to the vanity side wall is not complete, appears transparent and requires rectification to provide a suitable finish. Rectification will be required.

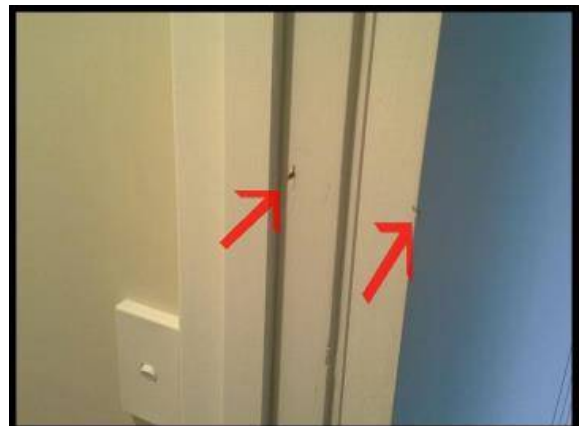
Door jamb/s are damaged and these areas will require maintenance, repair or replacement. Minor damage noted requiring paint repair. Rectification will be required.
