Visual Property Inspection Report

8 Purchase Road Toowong QLD 4550.

Report Type: Visual Dilapidation Building Inspection.

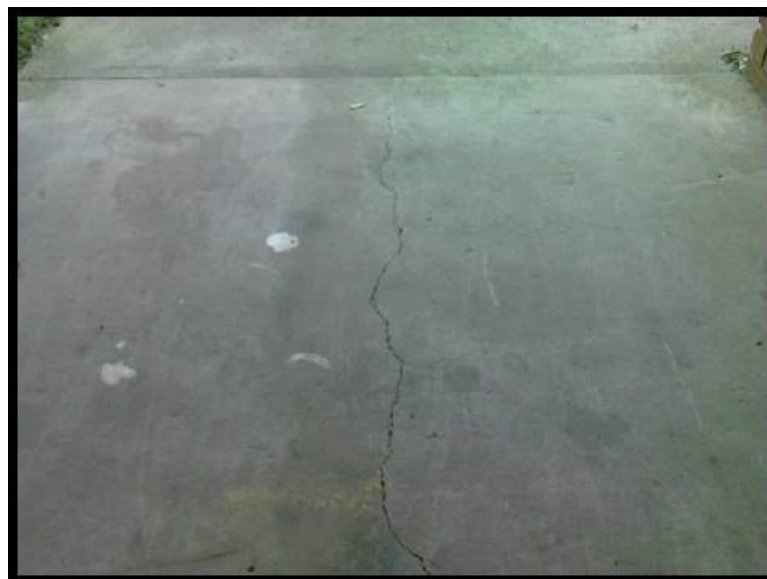
Appearance Defect Cracking:

Crack Type: Patched Located: North elevation. Width: 4mm. Length: 3.0M.

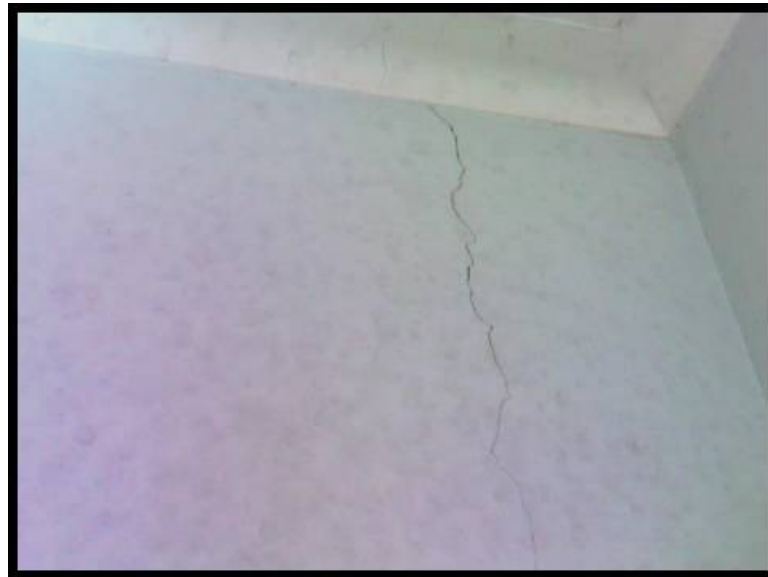
Serviceability Defect Cracking:

Crack Type: Random crazing.

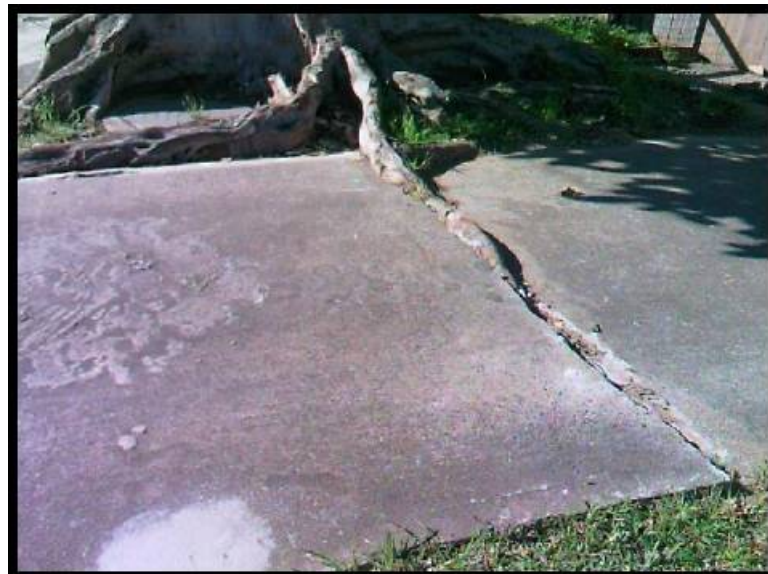
Structural Defect Cracking: Crack Type: Differential movement cracking Width: 15mm Length: 3.0M.

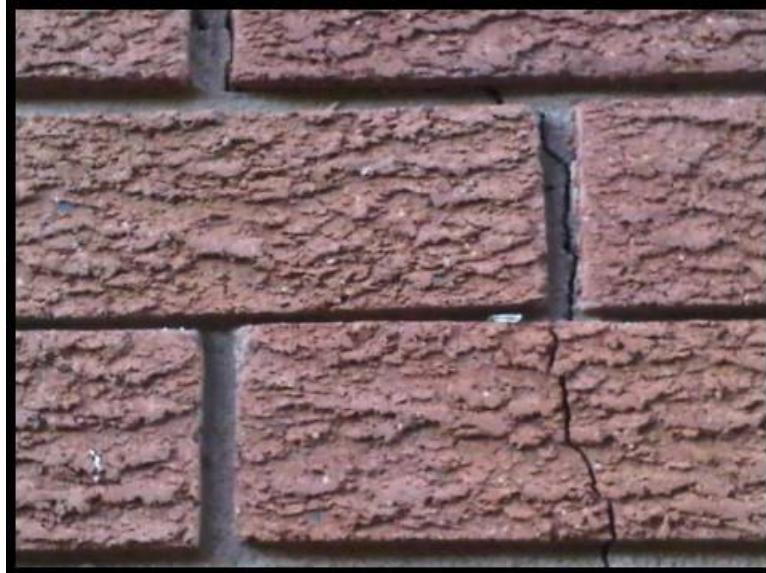
Structural Defect Cracking: Crack Type: Hairline cracking Located: West elevation Width: 1mm Length: 1.8M.

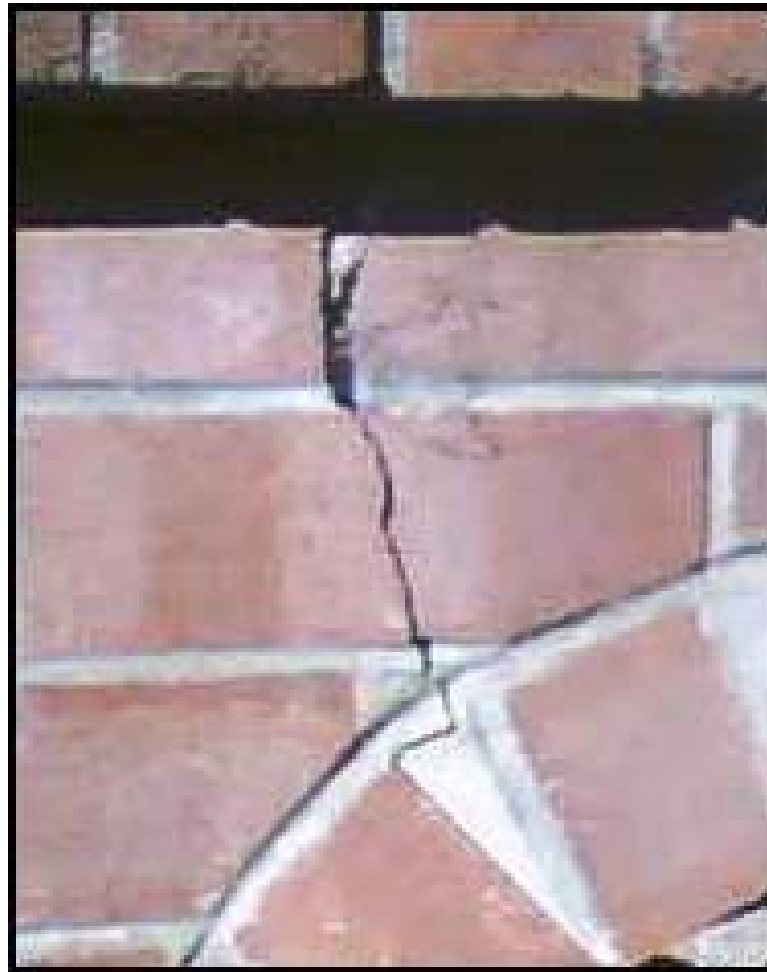
Appearance Defect Cracking: Crack Type: Stepped cracking Located: South elevation Width: 5mm. Length: 500mm.

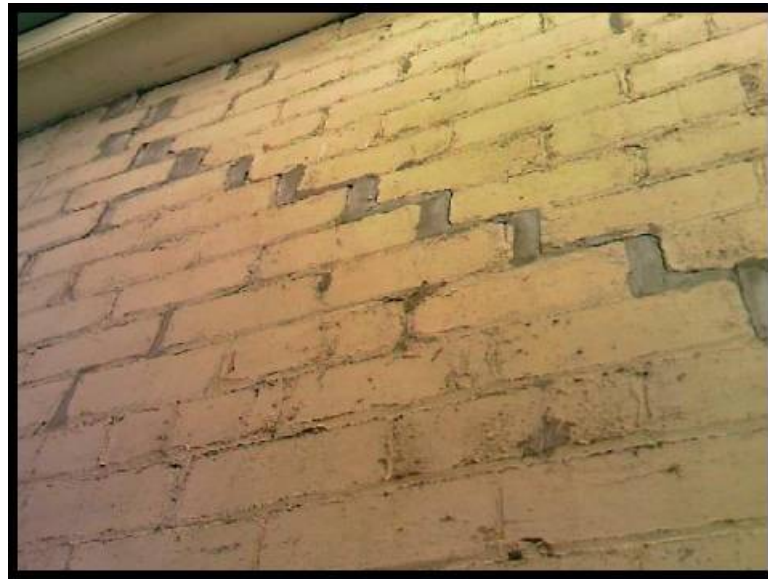
Structural Defect Cracking: Crack Type: Stepped cracking Located: North elevation Width: 10mm Length: 3.6M.

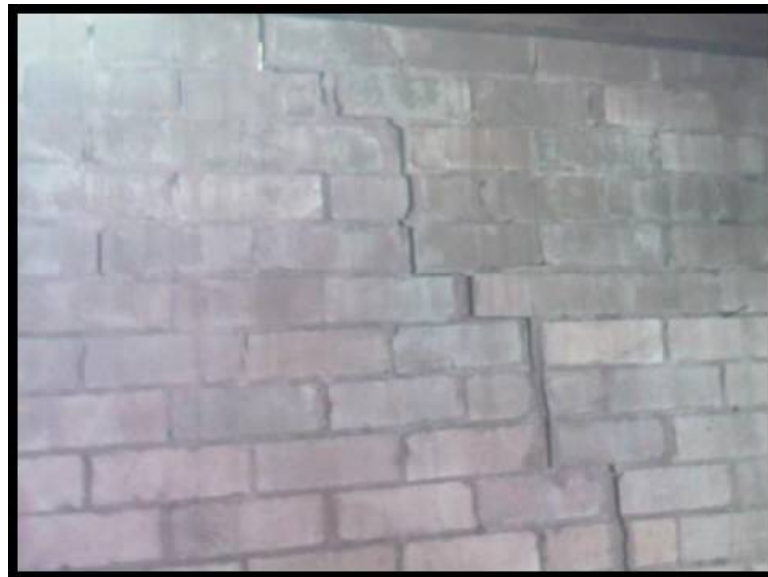
Located to the sub floor rear of garage.

Crack Type: Vertical cracking Located: North elevation Width: 3mm Length: 1.2M.

Crack Type: Vertical and stepped cracking Located: North elevation Width: 5mm Length: 2.4M.
