## Visual 90 Day Maintenance Property Inspection Report

Complies with Australian Standard AS 4349.1-2007

123 Nice Avenue, Smilington

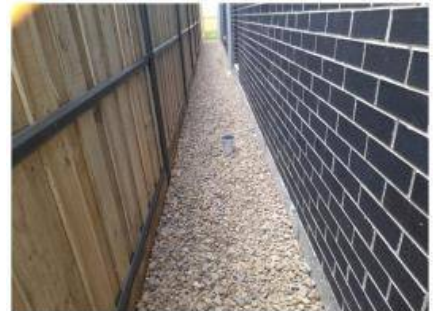
The surface water drainage at the left and right side of the property appears to be inadequate. Drains should be installed or ground levels changed to divert seepage and surface runoff water away from the building to prevent possible structural damage. Additional drainage should be connected to a stormwater drainage system.

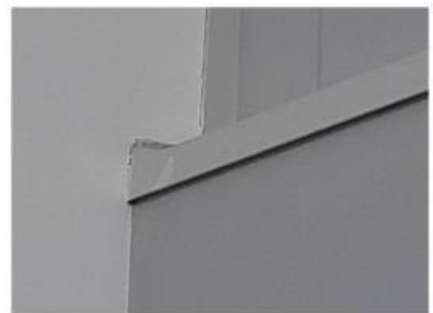
Flashing to junction of upper level cladding and lower level brickwork is not or does not appear to be correctly set into the brickwork. This can allow water penetration and should be rectified.

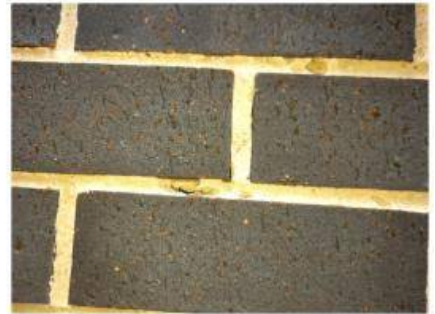
Mortar joints between brickwork require re pointing in areas. Rectification will be required.

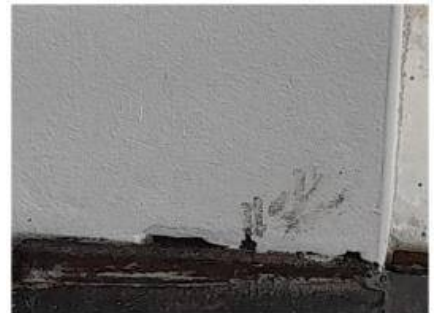
Minor repairs to render and paint touch ups are required.

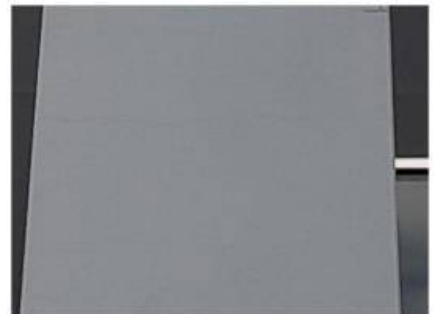
Shrinkage cracks are evident to rendered wall areas. This cracking generally occurs during the curing process of construction. Cracking of this type is an appearance defect and is not considered to be of a structural nature. Some repairs may be required prior to next painting to provide a suitable finish.

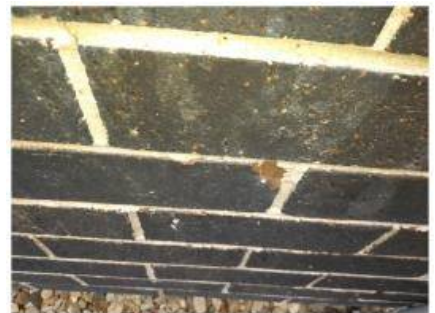
Brickwork is damaged and will require repairs and or replacement.

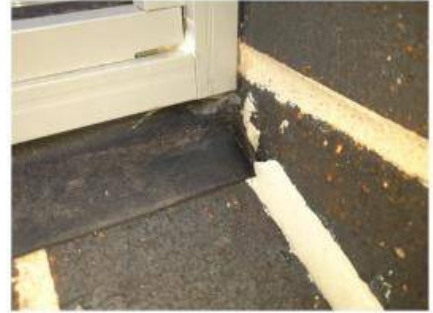
Recommend the junction of the window sills and brick sills be sealed with a flexible sealant to prevent water entry into wall cavity.

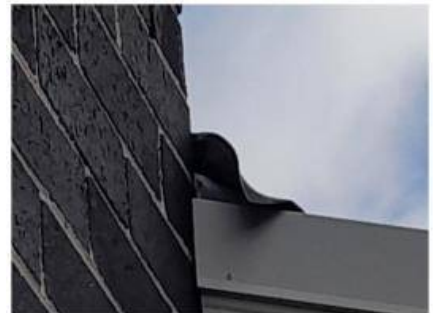
Potential water leak noted. Repair to the flashings are required.

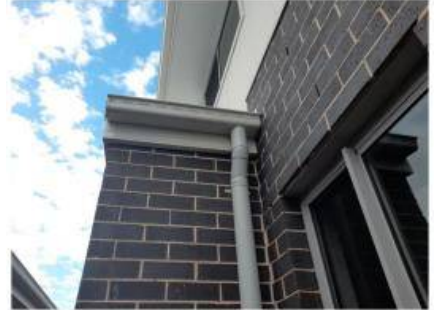
Downpipes appear to be connected to the stormwater dispersal system, however, correct connection can only be confirmed with a smoke test. The design and position of the guttering is such that during wet conditions it appears that the gutter may back flow into the eave or building. Recommend the area be evaluated during wet conditions. Some modifications may be required.

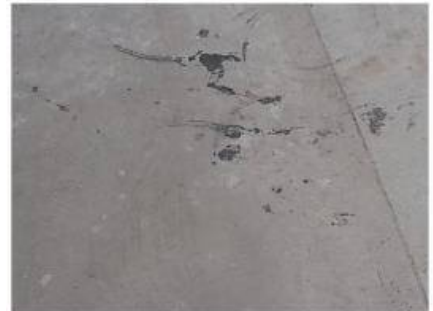
Concrete floor is stained. Rectification will be required.

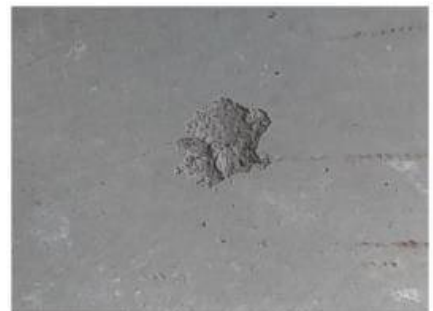
Surface of the concrete floor is damaged and will require repair.

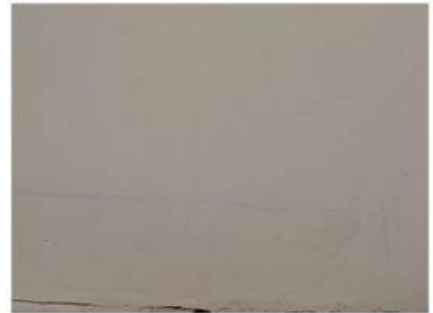
Defective or poor surfaces were noted to ceiling materials. Minor paint touch ups are required. Rectification will be required.

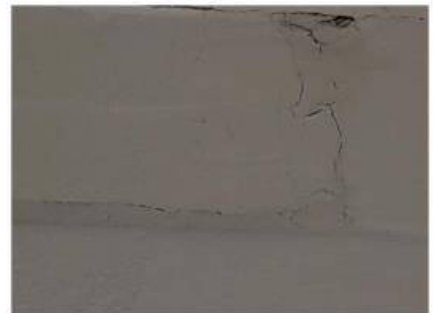
Defective or poor surfaces were noted to some sections of the wall materials. Rectification will be required.

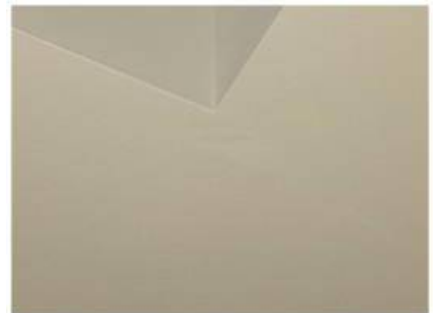
Minor paint touch ups are required.

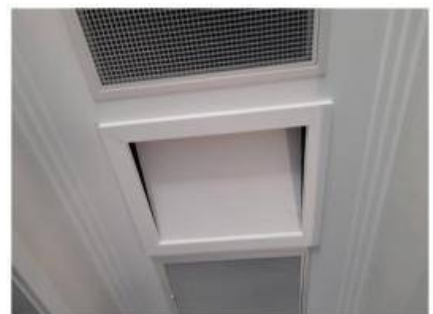
Recommend the manhole cover be cut to size. Rectification will be required.

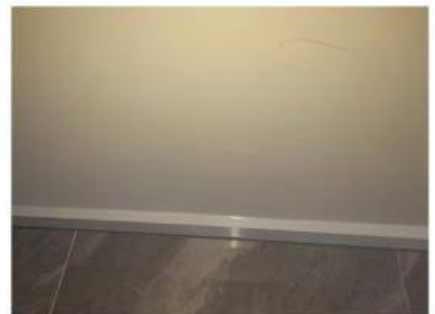
Minor repairs and paint touch ups are required.

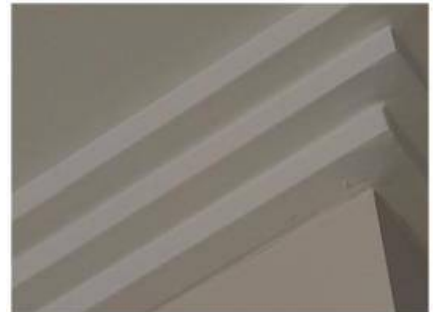
Defective or poor surfaces were noted to ceiling materials.  
Rectification will be required.

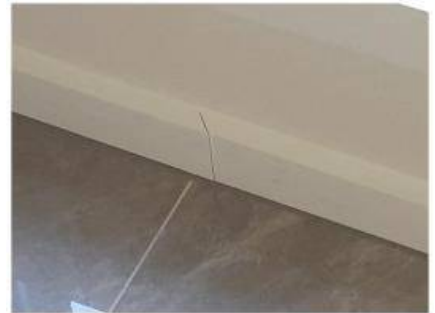
Minor repairs are required.

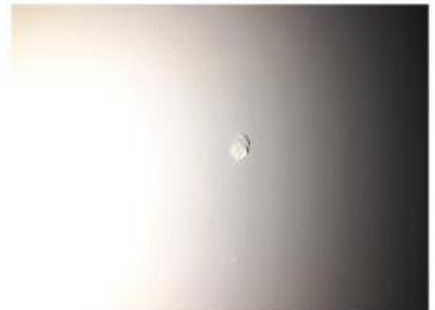
Defective or poor surfaces were noted to some sections of the wall materials. Rectification will be required.

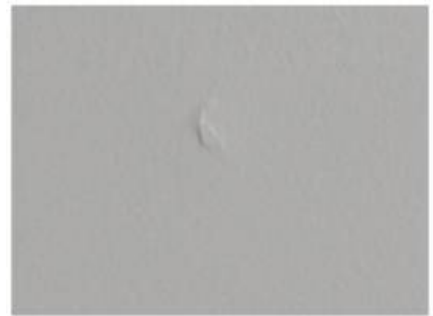
Defective or poor surfaces were noted to ceiling materials.  
Rectification will be required.

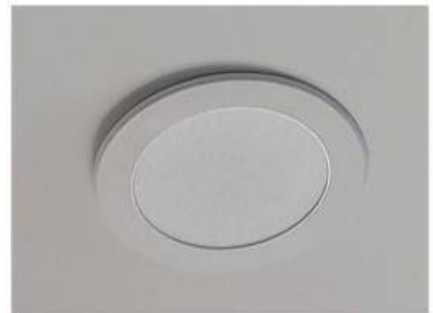
Down light requires re fixing to ceiling.

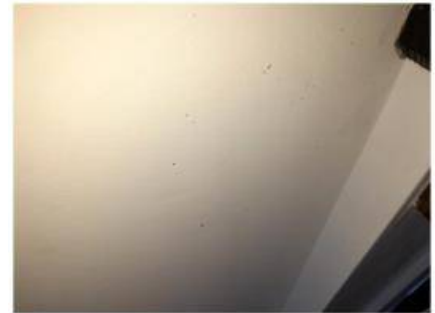
Minor paint touch ups are required.

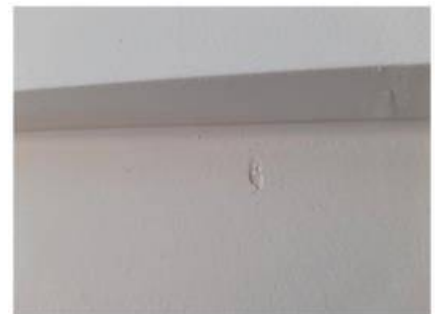
Defective or poor surfaces were noted to some sections of the wall materials. Rectification will be required.

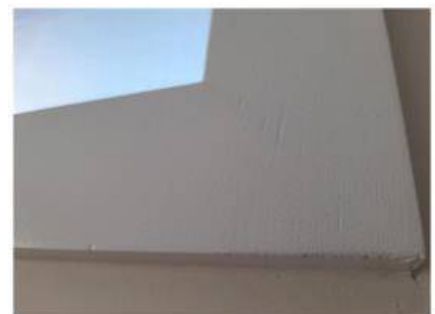
Minor repairs are required.

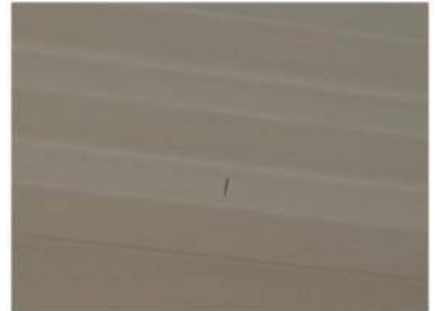
Defective or poor surfaces were noted to ceiling materials.  
Rectification will be required.

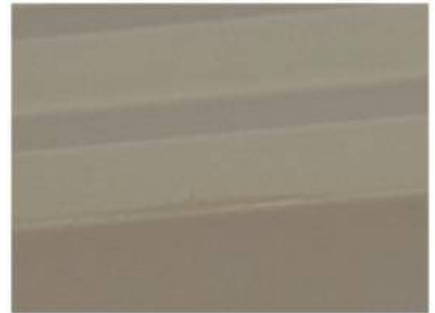
Minor paint touch ups are required.

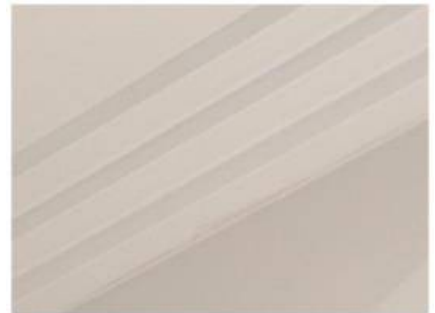
Minor paint touch ups are required.

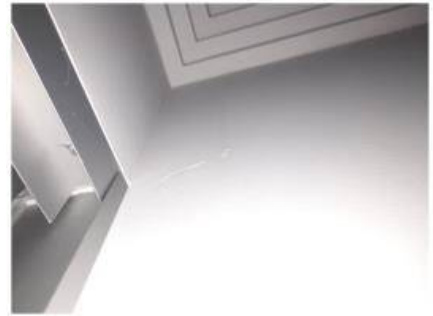
Defective or poor surfaces were noted to some sections of the wall materials. Rectification will be required.

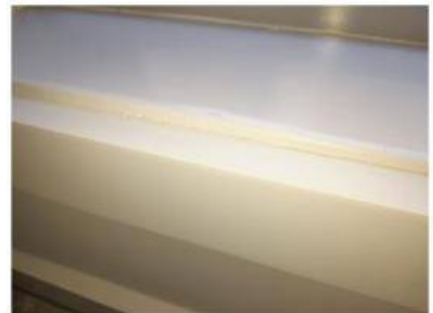
Minor repairs are required to window reveal.

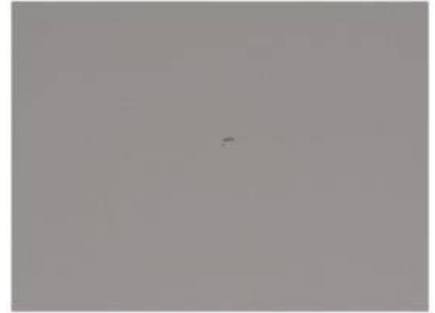
Defective or poor surfaces were noted to ceiling materials. Rectification will be required.

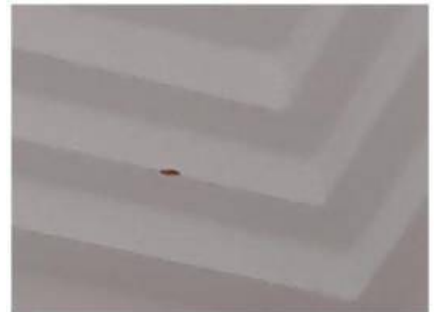
Minor paint touch ups are required.

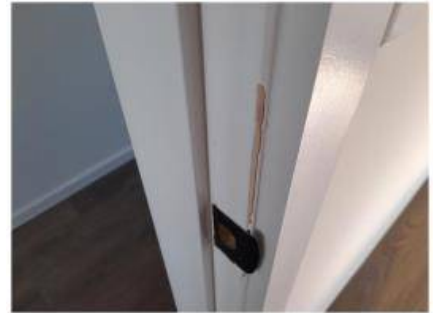
Minor repairs and paint touch ups are required.

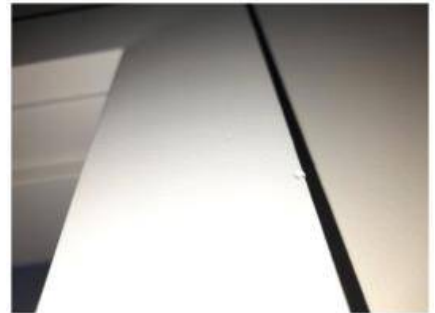
Minor repairs are required.

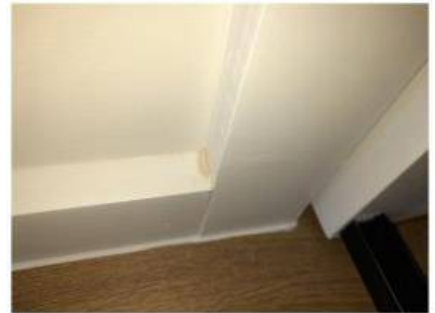
Minor repairs are required.

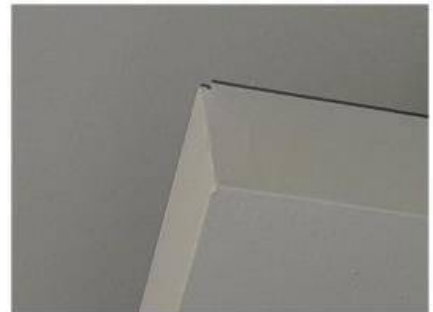
Defective or poor surfaces were noted to ceiling materials. Rectification will be required.

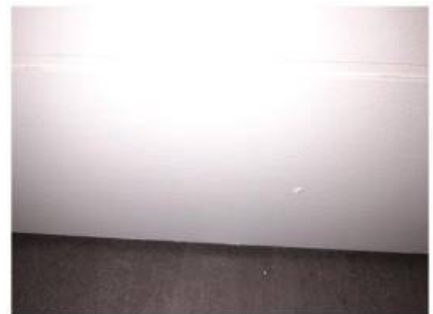
Defective or poor surfaces were noted to some sections of the door. Rectification will be required.

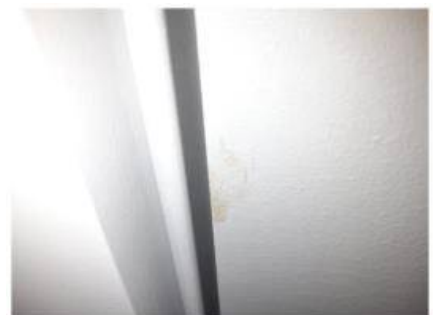
The condition of the door hardware is generally acceptable. Minor paint touch ups are required.

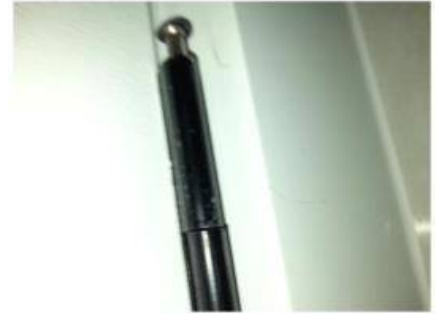
Minor repairs and paint touch ups are required.

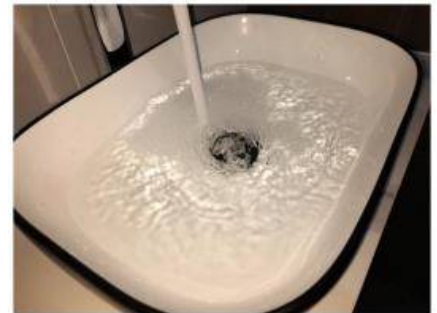
The basin & taps appear serviceable. Drainage appears slower than normal and should be investigated by a licenced plumber.

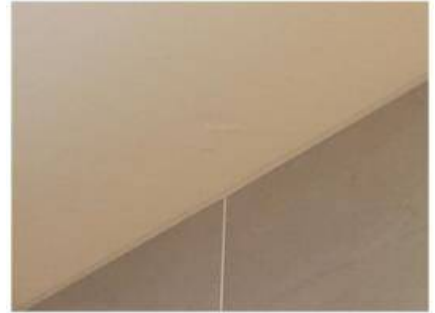
Defective or poor surfaces were noted to ceiling materials. Rectification will be required.

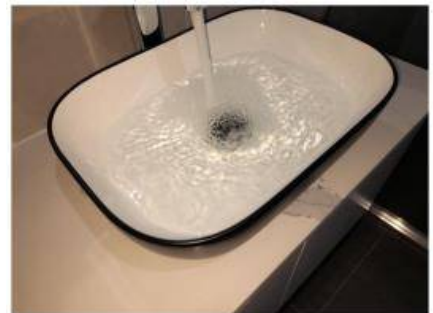
The basin & taps appear serviceable. Drainage appears slower than normal and should be investigated by a licenced plumber.

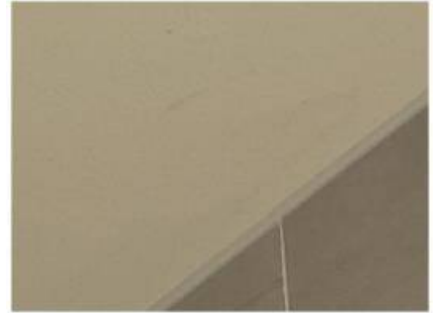
Defective or poor surfaces were noted to ceiling materials.  
Rectification will be required.

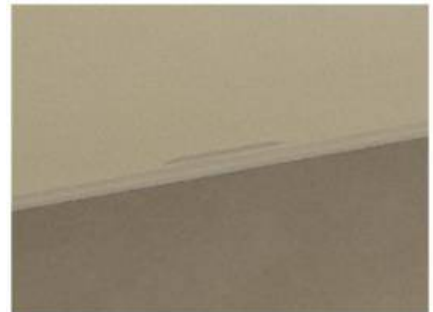
Minor paint touch ups are required.

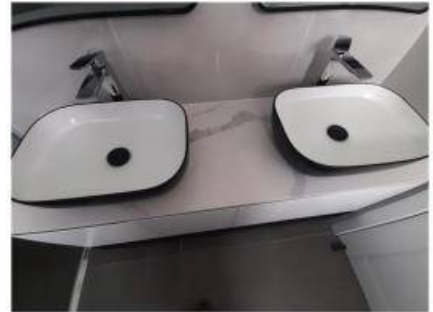
The basins & taps appear serviceable. Drainage appears slower than normal and should be investigated by a licenced plumber.

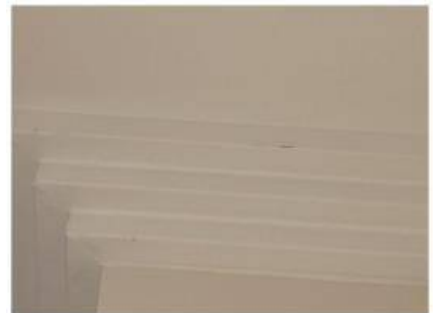
Minor paint touch ups are required.

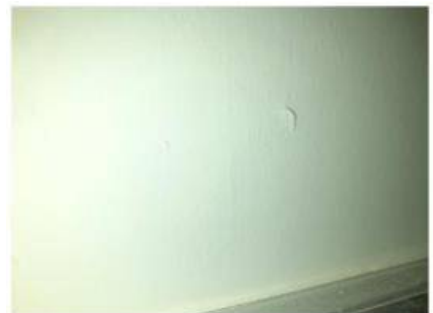
Defective or poor surfaces were noted to some sections of the wall materials. Rectification will be required.

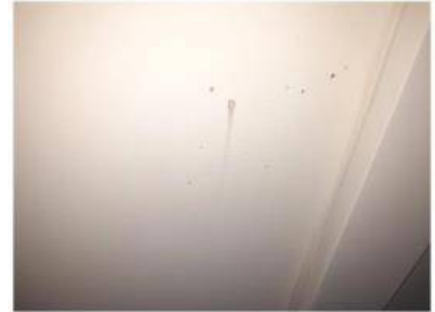
Minor paint touch ups are required.

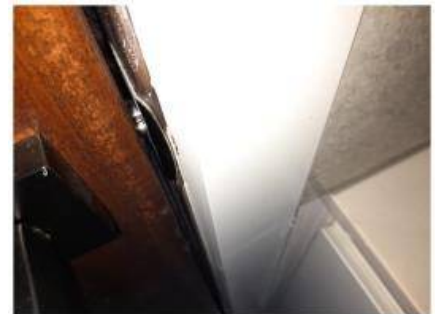
Minor repairs and paint touch ups are required.

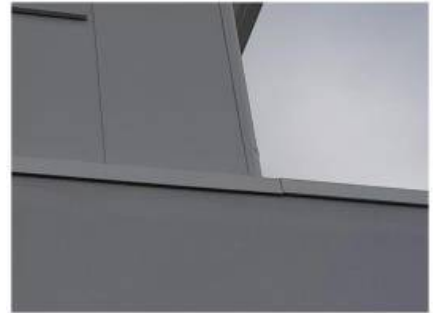
We recommend that flashings to junction of upper level cladding and lower level brickwork be monitored for possible water ingress.
