Visual Property Inspection Report

Complies with Australian Standard AS 4349.1-2007 & AS 4349.3-2010

5 Simple Place, Pleasantville

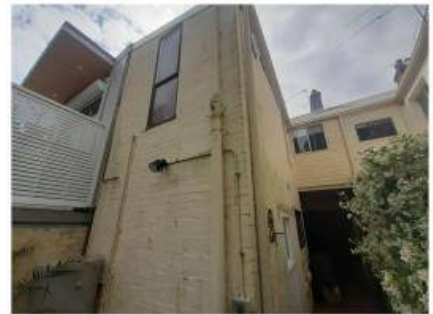
Paint deterioration was present to external surfaces. Maintenance and or repairs will be required.

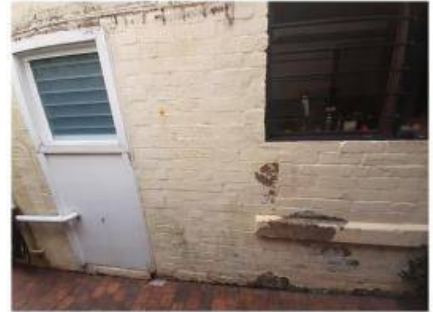
Cracks are evident to masonry. Visible cracking appears minor. Periodic maintenance may be required. Please refer to section of this report - CRACKING OF BUILDING ELEMENTS for additional details.

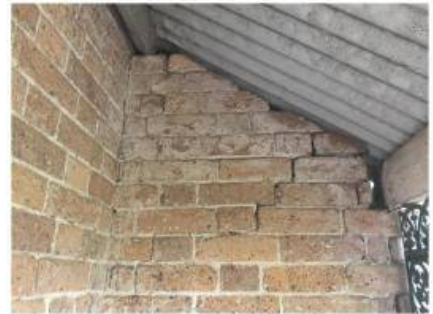
Vents and or weep holes are not present to the base of brick walls. The absence of vents and or weep holes can lead to ventilation and dampness problems. Recommend brick vents and or weep holes be installed to comply with current Standards.

Estimated cost from: \$1200.

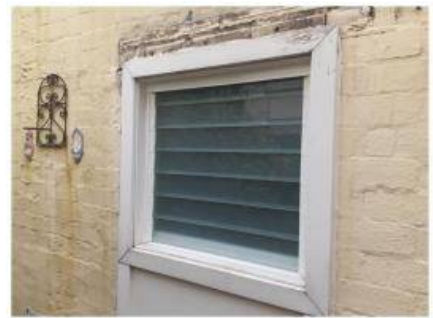
Rear elevation.

Paint is peeling off the window frames and maintenance is required. Minor maintenance and or repairs are required prior to next repainting.

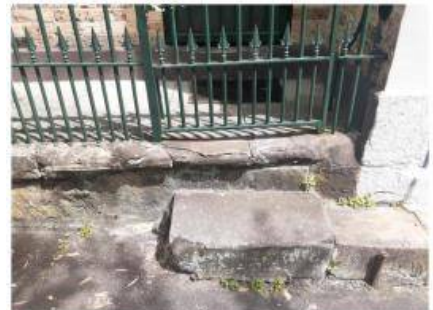
Front elevation.

The stairs are constructed primarily from bricks. The stairs are constructed primarily from masonry. Stair tread/s is not level and should be rectified. Rise and going (height & depth) of treads is hazardous and does not comply with current Standards. Recommend these areas be modified.

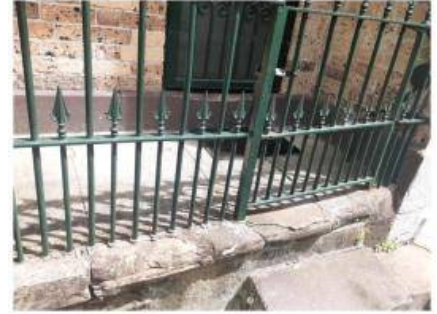
Damage is noted to the floor area. Damaged areas require repair or replacement.

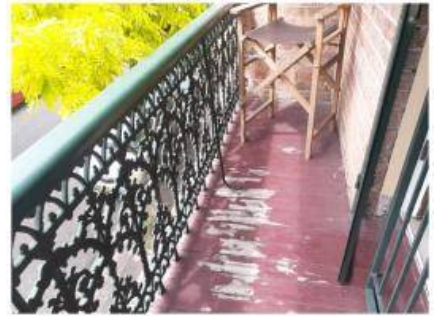
The handrails and balustrades do not comply with Standards for height and or spacing. Recommend they be modified. Timber flooring finish is showing wear and tear. Recommend poor areas be refinished. Minor damage noted requiring surface repair. Moderate wood decay is present to the structure and decayed timbers should be replaced.

Estimated cost from: \$2000.

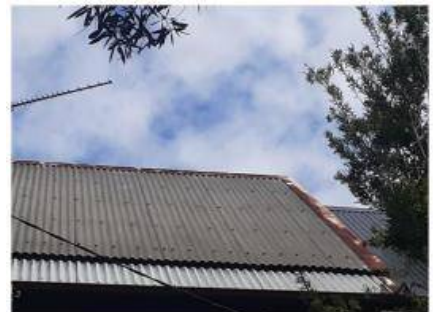
The flashing is in poor condition and requires repair or replacement. Roofing screws are rusted and should be replaced.

Estimated cost from: \$2000.

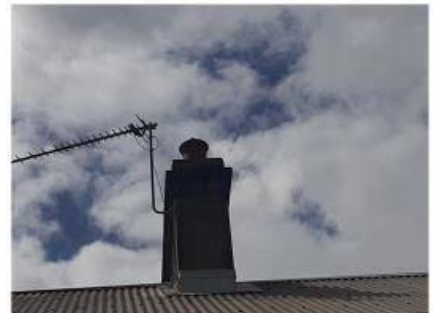
Fire boxes/places and chimneys need to be burning fuel to test if the units work correctly. This test is outside the scope of this inspection and a recommendation is that you have these units tested before you purchase. The practice of attaching aerials to the chimney can adversely affect the stability of the chimney and should be modified. Recommend aerial be removed and located on a roof, fascia or wall bracket.

Estimated cost from: \$600.

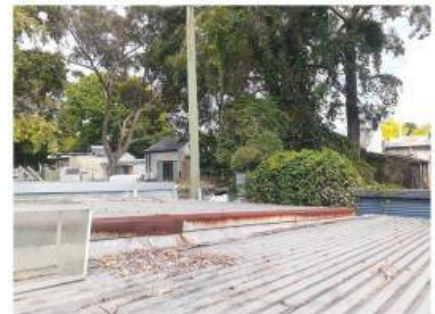
The overall condition of the roof coverings is fair. The flashing is in poor condition and requires repair or replacement. Roofing screws are rusted and should be replaced.

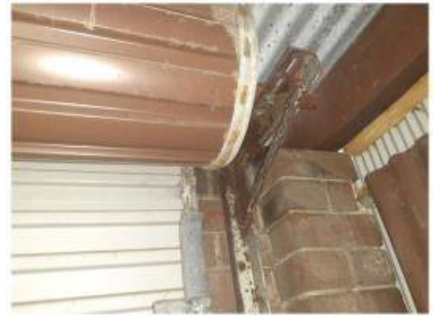
The main garage door is a roller shutter style door and is in fair condition. Rust is present to the door brackets and damaged areas will require treatment or replacement. The door requires adjustment or easing to ensure smooth operation.

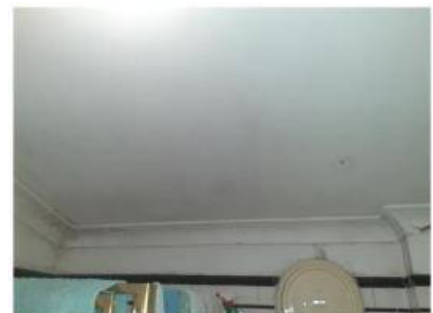
Ensuite.

Peeling paint was noted to ceilings. Mould was noted on the ceiling lining. Mould should be further investigated by an expert in mould detection and analysis.

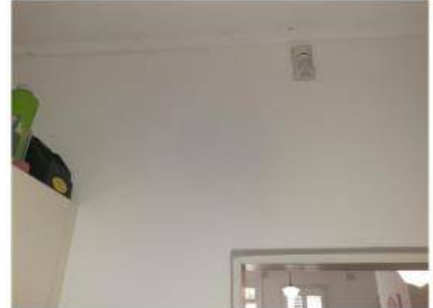
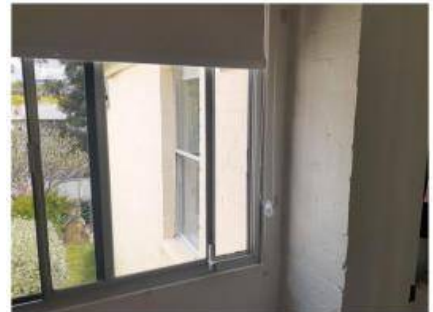
Kitchen. Sunroom.

Settlement cracks are evident to wall areas. Maintenance and repairs are required prior to next repainting. Please refer to section of this report - CRACKING OF BUILDING ELEMENTS for additional details.

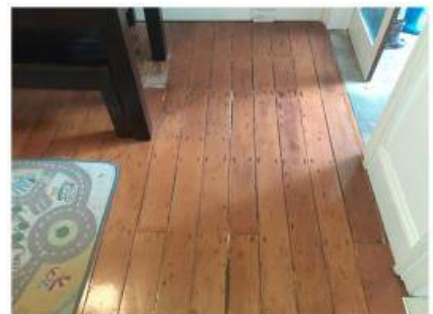
Main bedroom. Lounge room. Dining room.

Floors are uneven and recommend that the re-leveling of the uneven floor area/s be considered. Excessive movement was noted to timber floors. Additional support is required to the flooring members to remove excessive movement. Excessive gaps were evident between floorboards. Timber flooring has shrunk since installation and relaying will be required to rectify finish. Timber flooring finish is showing wear and tear. Damage noted requiring surface repair.

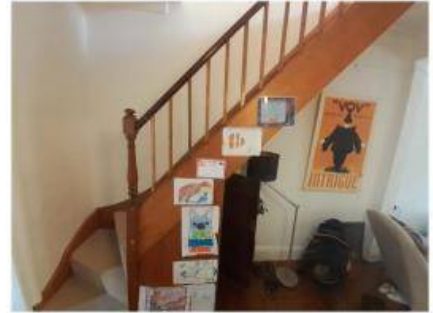
The stairs are constructed primarily from timber. The stair treads squeak and require maintenance. The handrails and balustrades do not comply with Standards for height and or spacing. Recommend they be updated.

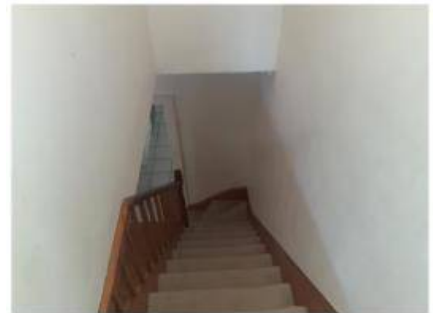
Head height over the stairs is low, does not comply with Standards and may be hazardous. Recommend this area be modified.

Estimate cost from: Not available (Quotations should be commissioned)

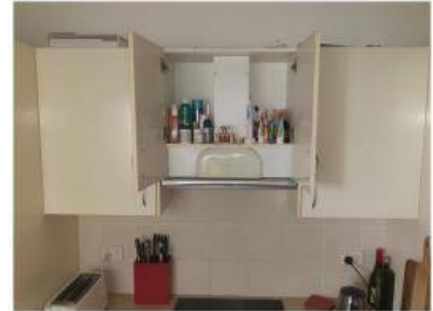
Stone benchtop is chipped and will require repair or replacement. A range hood is present however, it does not appear to be ducted correctly. Recommend the unit be ducted to the external air. Wear and tear is noted to cabinets and some maintenance or repairs will be required.

Estimate cost from: Not available (Quotations should be commissioned)

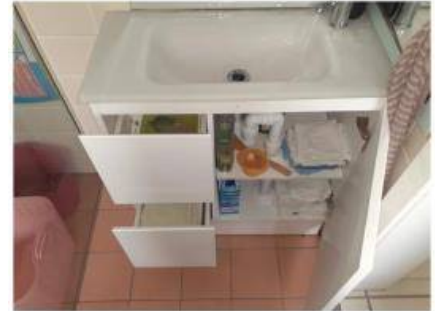
Wear and tear is noted to vanity cabinet. Consider maintenance and adjustments to various doors/drawers to provide smooth operation.

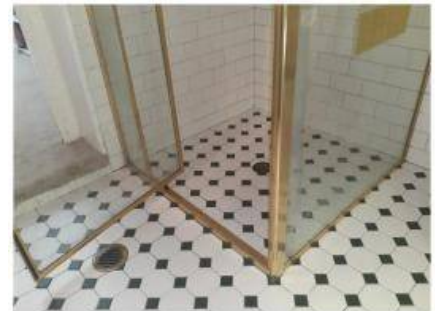
The shower recess was tested and there was no visible water penetration to surrounding areas. **IMPORTANT NOTE:** This test may not reveal water leaks until the shower is put into constant use and surrounding areas monitored over a period of time. Glass to the shower screen is delaminating, hazardous, and should be changed.

Estimated cost from: \$600.

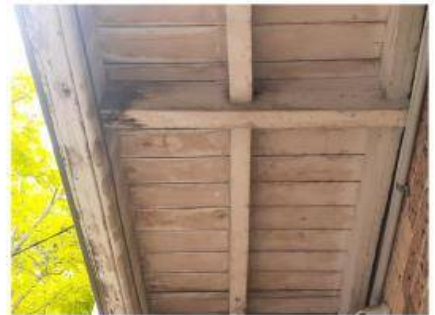
Fascia timbers: Balcony timbers:

Visible timber damage appears moderate. Please refer to the building report for details or if a building inspection was not commissioned we recommend a builder inspection and report on the property. Refer to the definitions section of this report - TERMS & LIMITATIONS - Timber Damage.

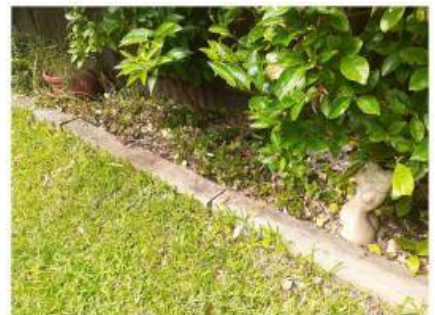
Untreated landscaping timbers should be removed or replaced with a treated timber or non timber alternative. If replaced with timber, ensure appropriate durability rating for external use.

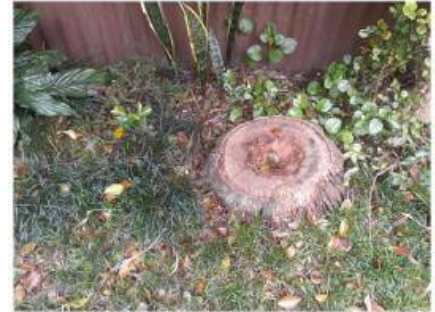
Tree stumps should be removed.

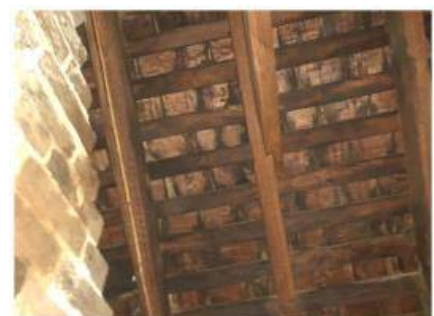
Rafters.

Main bedroom.
