Visual Property Inspection Report

Complies with Australian Standard AS 4349.1-2007

Unit 1, 1-5 Perfect Street, Happyville

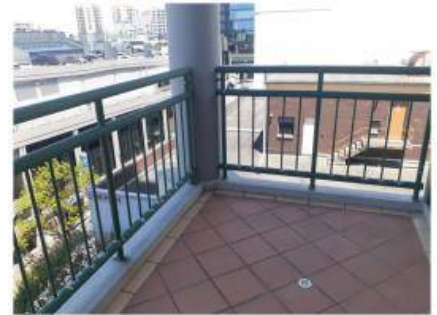
The handrails and balustrades do not comply with Standards for height and or spacing. Recommend they be modified.

Estimate cost from: Not available (Quotations should be commissioned)

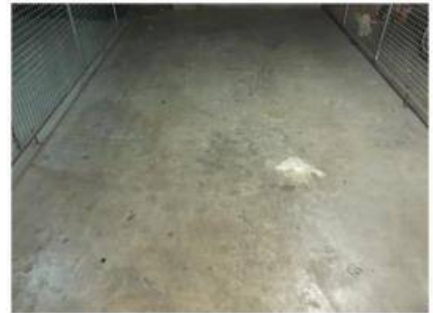
Concrete floor is stained and marks may not be able to be removed.

Estimated cost from: NOTE ONLY.

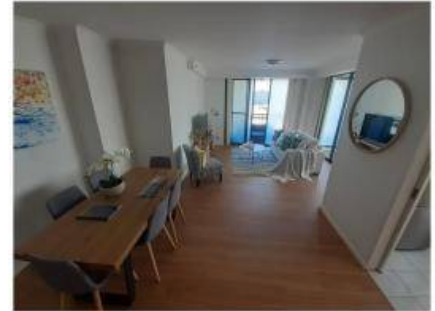
Both floorcoverings and furnishings were present and restricted inspection within this area. We note some timbers have been either heavily painted, filled or a combination of both. This is not necessarily unusual however, it does make determining evidence of timber pest attack more difficult and in some cases, can mask damaged timbers. Inspection was limited in the following locations and or areas: All internal areas.

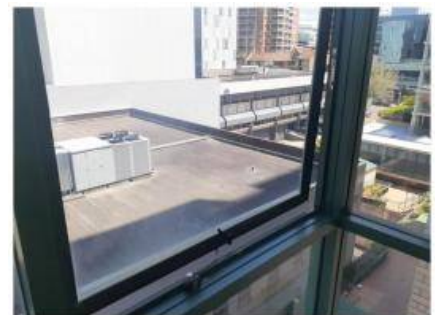
Damaged window sashes were noted and will require maintenance, repair or replacement.

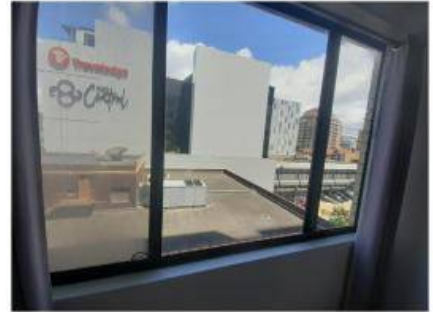
Maintenance and adjustments are required to some windows to ensure smooth operation. The windows show signs of age and weathering. Periodical maintenance will be required.

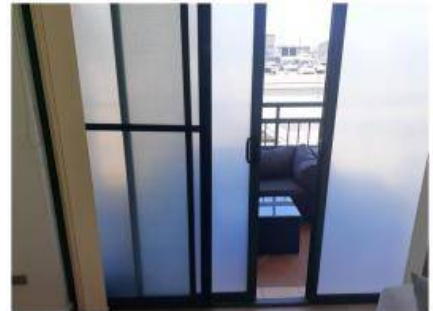
The sliding door/s have poor operation and require adjustment and or repair.

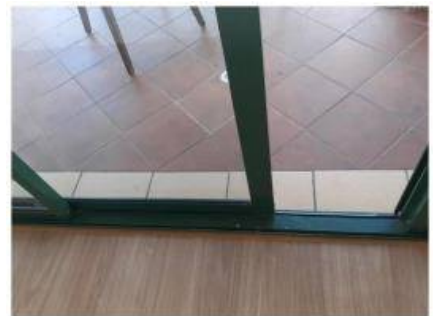
Door frames are scratched and will require repairs prior to next repainting.

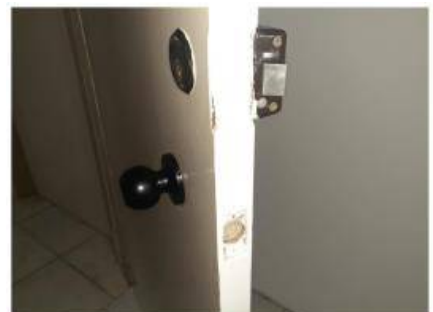
Minor repairs are required to door/s.

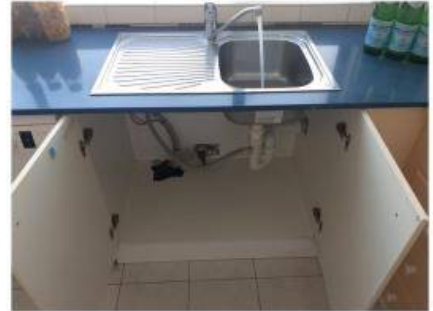
Recommend kitchen cupboards be upgraded. Service penetrations through cabinets have been poorly finished and should be sealed or finished tightly to fixtures. Wear and tear is noted to cabinets and some maintenance or repairs will be required. Maintenance and adjustments should be considered to doors/drawers to provide smooth operation.

Estimated cost from: \$5000.

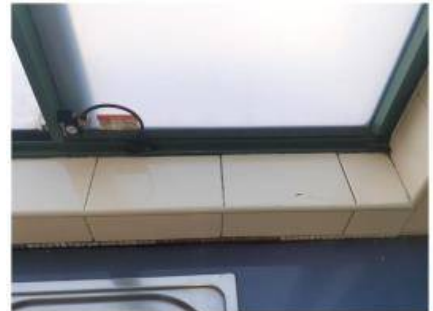
Some drummy, loose, cracked tiles were noted and damaged areas will require repair and or replacement.

Estimated cost from: \$250.

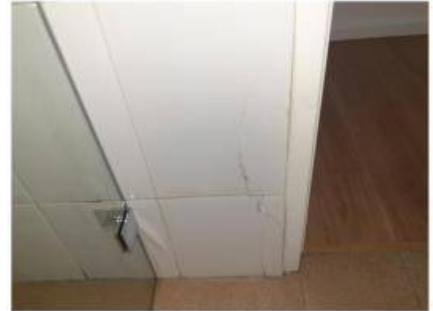
Some drummy, loose, cracked tiles were noted and damaged areas will require repair and or replacement.

Estimated cost from: \$250.

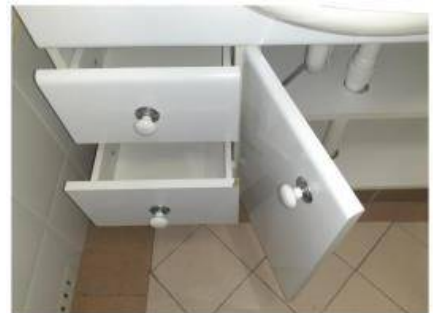
Wear and tear is noted to vanity cabinet. Consider maintenance and adjustments to various doors/drawers to provide smooth operation.

Estimated cost from: \$250.

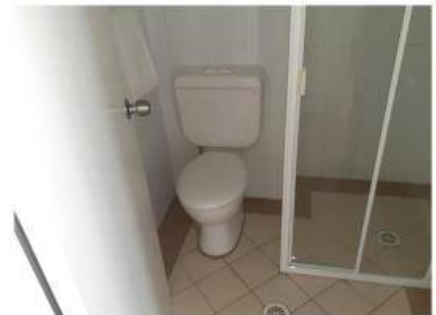
The toilet appears to be in working order. Toilet area is restrictive and the door swings inwards. In case of an emergency the door cannot be readily removed from the outside. Recommend liftoff hinges be installed to the door to comply with current Standards.

Estimated cost from: \$450.
