Visual Defects (Handover) Property Inspection Report

Complies with Australian Standard AS 4349.1-2007

11 Sweet Lane, Kind Cove

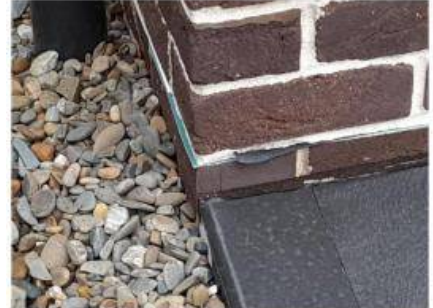
The ground levels are close or covering the damp proof course material and should be lowered to prevent dampness problems. The height of a DPC, or flashing serving as a DPC is recommended be not less than 150 mm above the adjacent ground level, 75 mm above the finished surface level of adjacent paved, concrete or landscaped areas that slope away from the wall or 50 mm above finished paved, concrete or hard landscaped areas. Base of some walls are below the external soil levels and may be subject to lateral dampness or water entry. Recommend the area be closely monitored for water penetration.

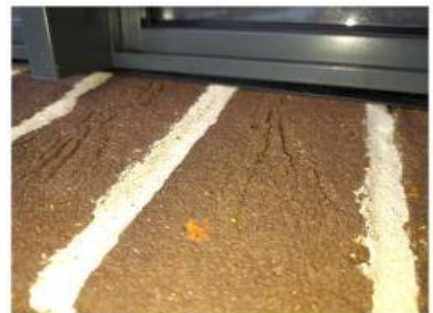
The clearance under the window sills is not sufficient to allow for settlement. Clearances should be modified to prevent damage to windows, cladding and internal finishes when the timber frame settles. Clearances should be a minimum of 5mm for single or lower levels and 10mm for second storey windows.

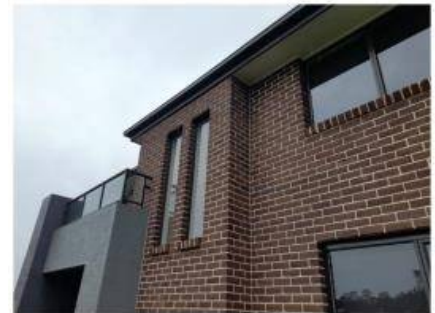
Downpipes appear to be connected to the stormwater dispersal system, however, correct connection can only be confirmed with a smoke test. The design and position of the guttering is such that during wet conditions it appears that the gutter may back flow into the eave or building. Recommend the area be evaluated during wet conditions. Some modifications may be required.

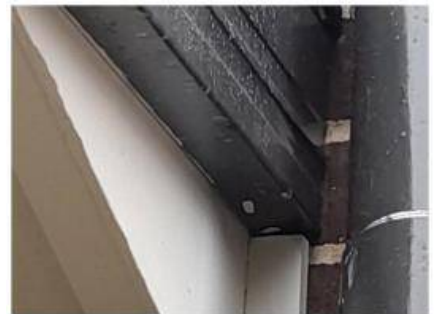
Minor paint touch ups are required.

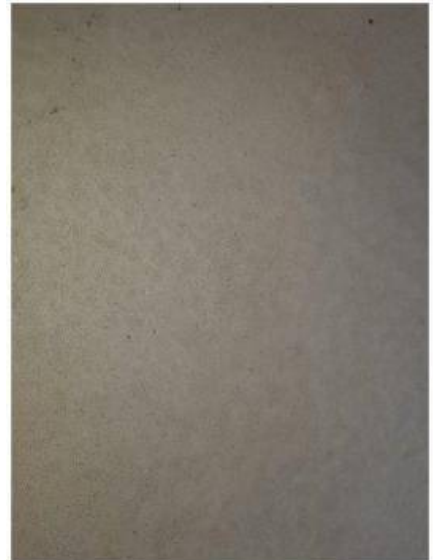
The concrete floor shows signs of minor cracking. Please refer to section of this report - **CRACKING OF BUILDING ELEMENTS** for additional details. Surface of the concrete floor is damaged and will require repair.

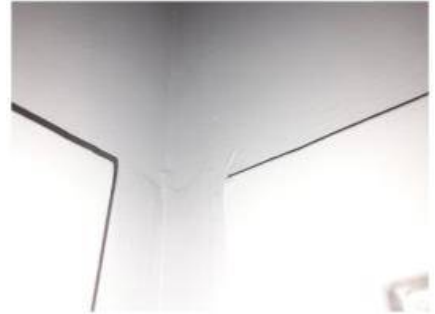
Minor paint touch ups are required. Defective or poor surfaces were noted to some sections of the wall materials and repairs are required.

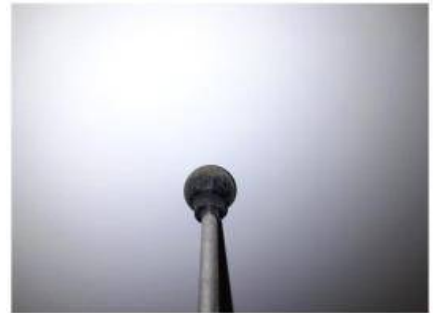
Nails are popping and are visible. This is generally due to movement in the timber framing.

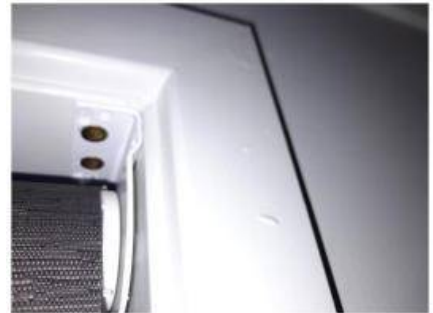
Door jamb/s are damaged and these areas will require maintenance, repair or replacement. Minor paint touch ups are required.

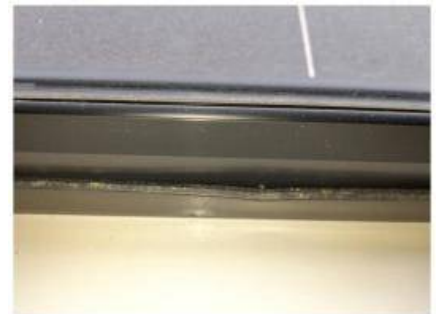
The condition of the door hardware is generally acceptable. The sill to sliding door is damaged and requires repair.

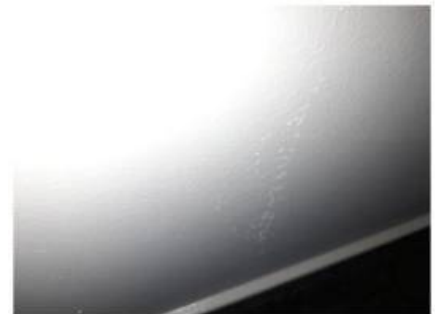
Defective or poor surfaces were noted to some sections of the wall materials and repairs are required. Minor paint touch ups are required.

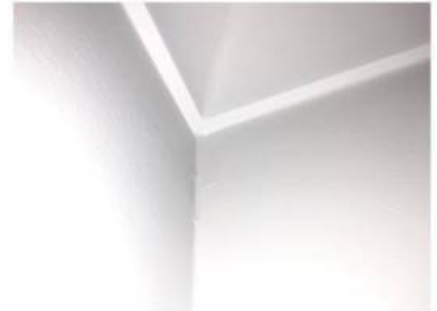
Defective or poor surfaces were noted to some sections of the wall materials and repairs are required. Minor paint touch ups are required.

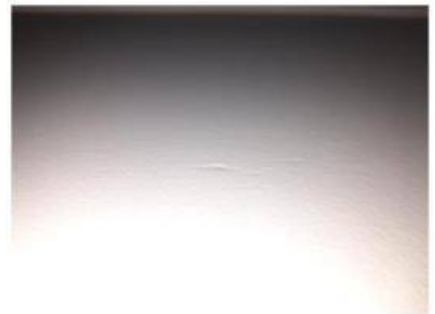
Defective or poor surfaces were noted to some sections of the wall materials and repairs are required.

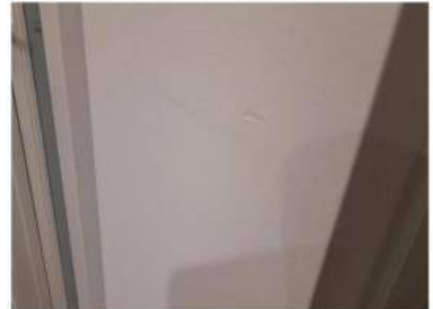
Defective or poor surfaces were noted to some sections of the wall materials and repairs are required.

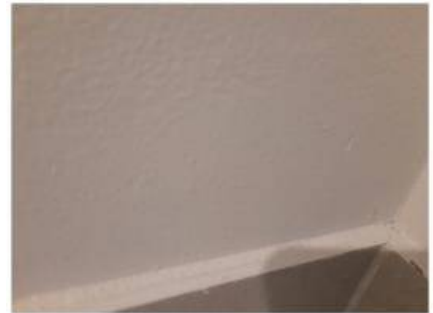
Defective or poor surfaces were noted to some sections of the wall materials and repairs are required.

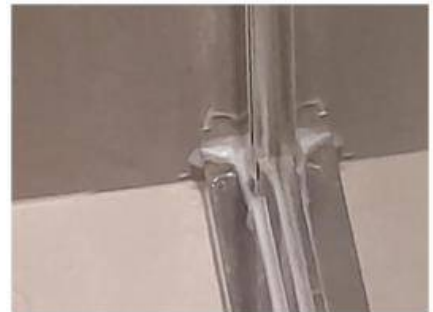
The shower recess was tested and there was no visible water penetration to surrounding areas. **IMPORTANT NOTE:** This test may not reveal water leaks until the shower is put into constant use and surrounding areas monitored over a period of time. Recommend that silicone to shower screen be tidied up.

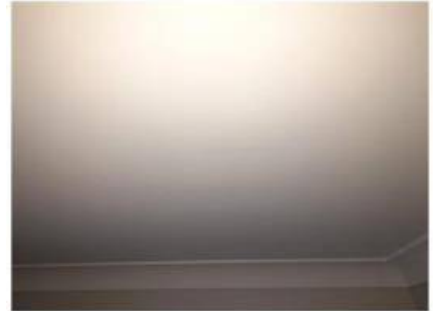
Defective or poor surfaces were noted to ceiling materials and repair will be required.

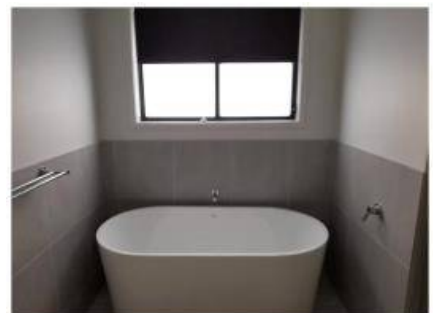
The condition of the window hardware is generally acceptable. Windows to this area do not comply with current laws requiring all windows two metres above ground level to be secured to prevent a child from falling. Openings are not to be greater than 125mm. This can be achieved by locks limiting the opening of the window or the installation of security screens or grills.

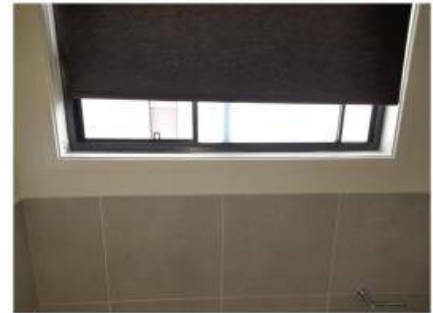
The condition of the window hardware is generally acceptable. Windows to this area do not comply with current laws requiring all windows two metres above ground level to be secured to prevent a child from falling. Openings are not to be greater than 125mm. This can be achieved by locks limiting the opening of the window or the installation of security screens or grills.

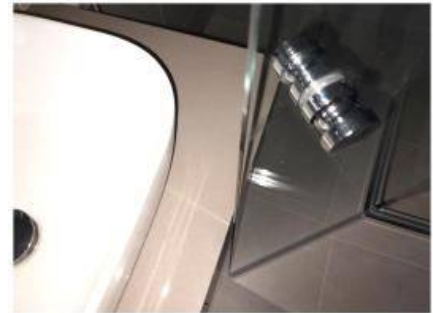
The shower recess was tested and there was no visible water penetration to surrounding areas. **IMPORTANT NOTE:** This test may not reveal water leaks until the shower is put into constant use and surrounding areas monitored over a period of time. Recommend a doorstop to be installed to shower screen door.

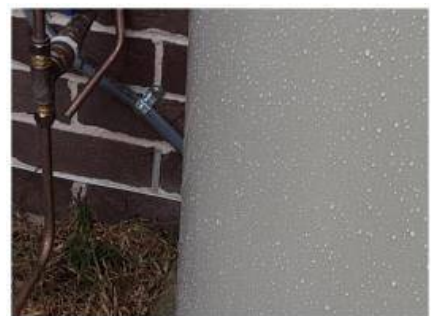
Mains electric hot water system: Mains pressure: Located externally: The hot water system appears to be in working condition. No specific tests other than running the hot water tap were carried out. No determination has been made as to the suitability or adequacy of the hot water system in relation to capacity or otherwise. Hot water overflow pipe should be diverted away from the external walls. Damp soil around the building may cause swelling and lead to heaving of structure and cracking to walls. Moisture also encourages termites into the area. We strongly recommend the overflow relief valve be connected to a drainage point. The hot water system was not in service at the time of inspection and accordingly no comment on this system is offered.

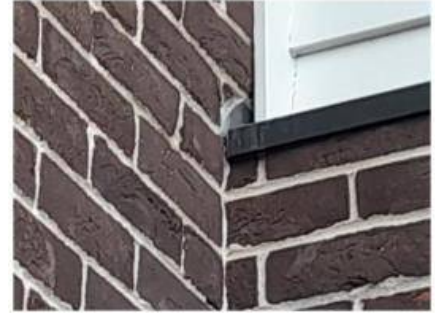
We recommend that flashings to junctions of upper level cladding and lower level brickwork be monitored for possible water ingress.
