Visual Timber Pest Inspection Report

Complies with Australian Standard AS 4349.3-2010

111 Happy Street, Pleasantville

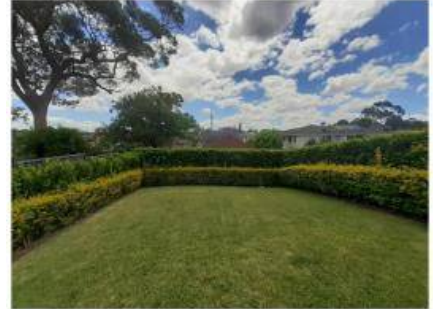
Inspection to the following fencing timbers was restricted in part by foliage - Left hand side fence. Right hand side fence. Rear fence.

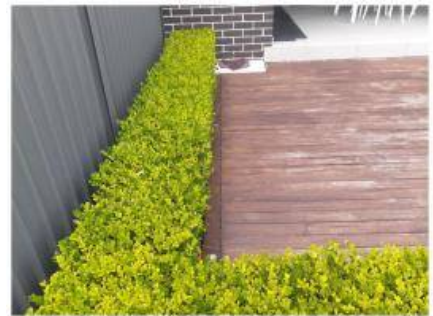
Decking timbers are in contact with soil. These should be modified to reduce the risk of concealed termite entry.

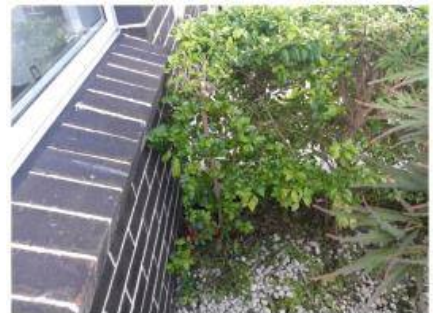
Trees, tree roots, vines or shrubs are close to or abutting the external walls of the structure. This can allow concealed termite entry and they should be removed.

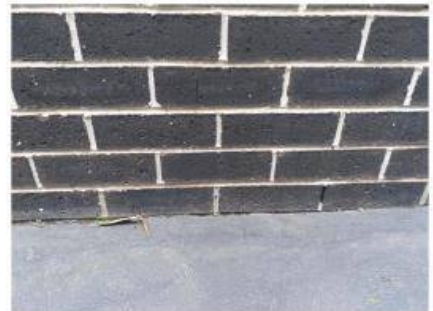
The external vents/weep holes are either covered completely or partly concealed. This can allow concealed termite entry and we recommend that all vents/weep holes be exposed and kept clear of soil, foliage, debris, stored items or other obstructions.

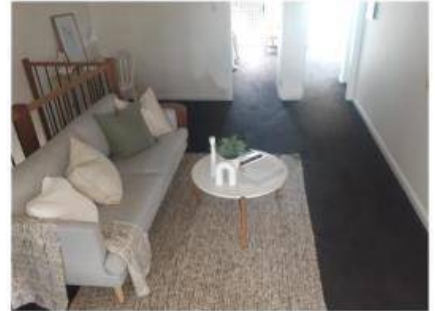
Both floorcoverings and furnishings were present and restricted inspection within this area.

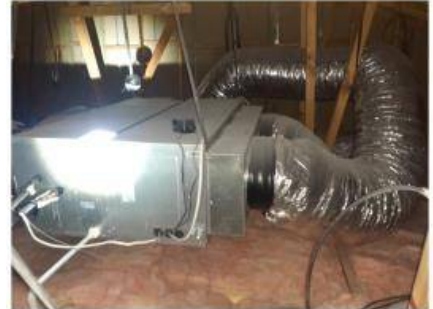
Sarking paper and insulation is present in the roof cavity. This restricted inspection to some roofing timbers. Removal of insulation is not within the scope of a standard visual building inspection report. Ducting associated with air-conditioning or heating restricted inspection. Air-conditioning or heating unit and associated ducting has blocked access to areas of the roof void restricting inspection. Inspection was restricted above the following locations and or areas: All internal areas.

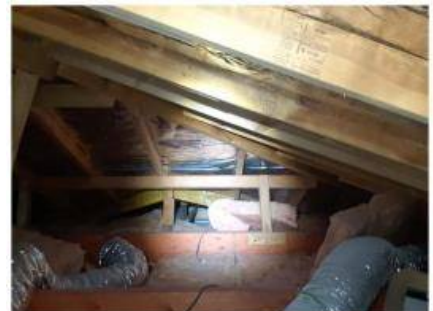
Inspection over the eaves and low areas to the perimeter of the building was restricted due to the low pitch and method of construction allowing only a limited visual inspection from a distance. Items such as top plates and ceiling and roof framing in these areas was not able to be fully inspected.

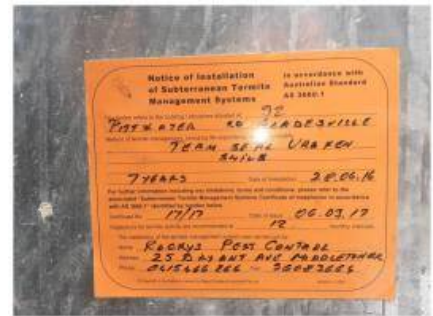
A notice indicates that the property may have been treated during construction in respect to protection against subterranean termite attack. We strongly recommend any prospective purchaser attempt to verify this information and obtain copies of all relevant documentation.
