Visual Building Stage Inspection Report

Complies with Australian Standard AS 4349.0-2007

100 Special Avenue, Koala Park

Visual Building PreLinings Stage Inspection

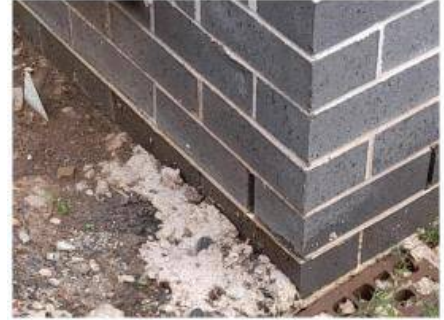
Western elevation.

The ground levels are close or covering the damp proof course material and should be lowered to prevent dampness problems. The height of a DPC, or flashing serving as a DPC is recommended be not less than 150 mm above the adjacent ground level, 75 mm above the finished surface level of adjacent paved, concrete or landscaped areas that slope away from the wall or 50 mm above finished paved, concrete or hard landscaped areas. The height of the ground level should be lowered to allow for landscape finishes.

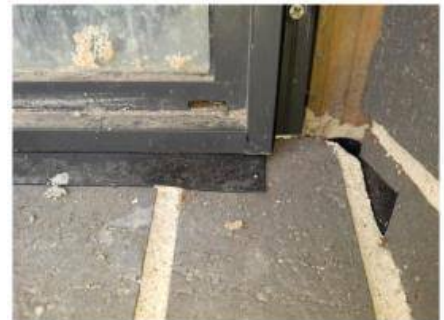
Northern elevation. Eastern elevation. Southern elevation. Western elevation.

The clearance under the window sills is not sufficient to allow for settlement. Clearances should be modified to prevent damage to windows, cladding and internal finishes when the timber frame settles. Clearances should be a minimum of 5mm for single or lower levels and 10mm for second storey windows.

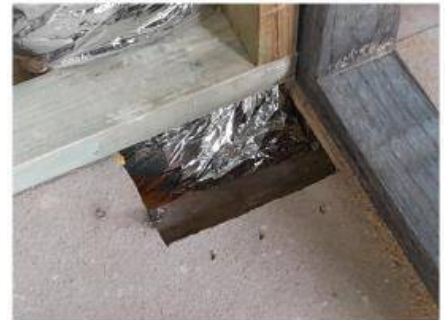
Recommend floor be completed to prevent possible injury.

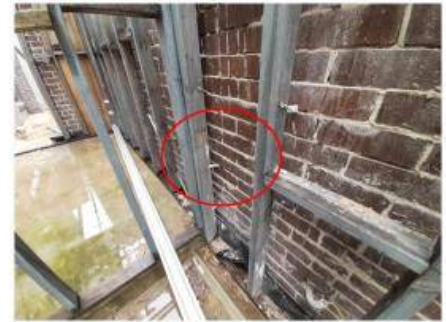
Some noggings are missing and should be installed.

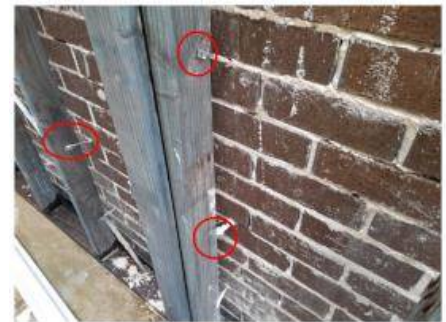
Brick ties are missing fixings and should be installed.

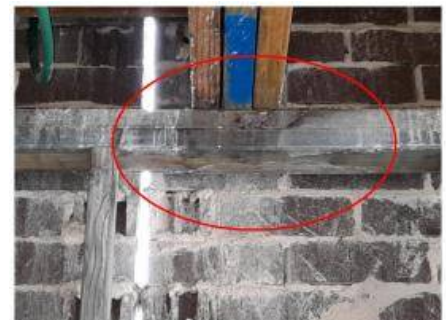
Recommend point load studs be installed below floor joists.

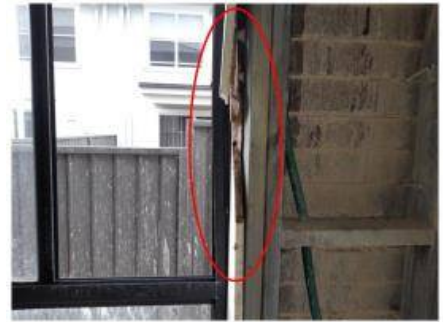
Window and reveal is damaged and requires replacement.

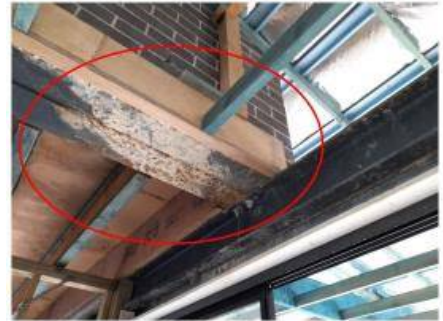
Beams above lintel are rusting and require treatment to prevent further deterioration.

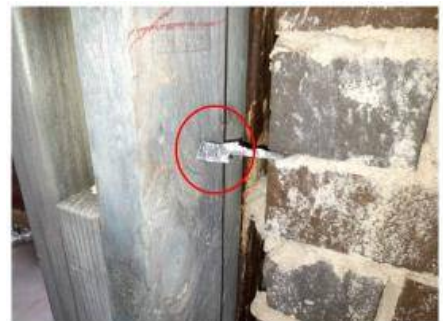
Brick ties are missing fixings and should be installed.

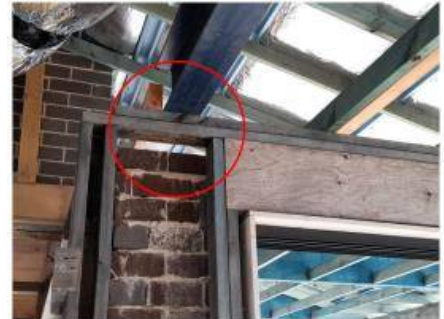
Recommend point load steel post be installed to support overhead beam. An engineer should be consulted to determine support type and method required. This area would be classes as a major defect.

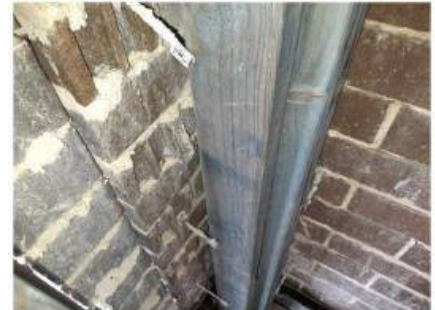
Brick ties are missing fixings and should be installed.

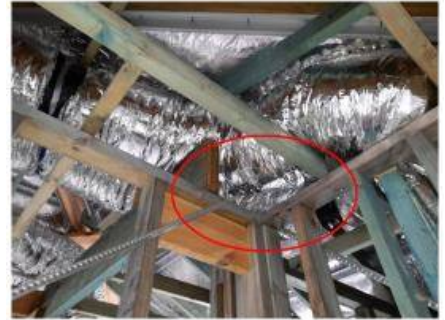
Ceiling trimming are missing and are required to adequately support the ceiling lining.

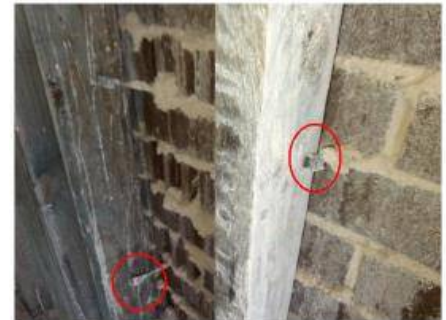
Wall Cavity:
Brick ties are missing fixings and should be installed.

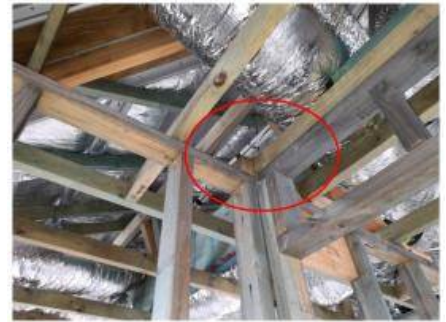
Ceiling trimming are missing and are required to adequately support the ceiling lining.

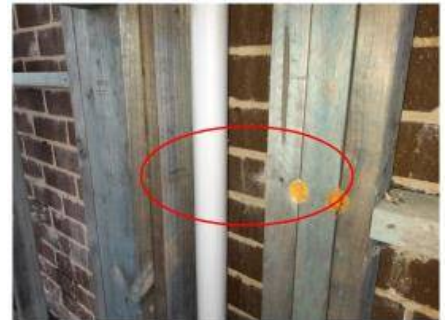
The noggin is missing and should be installed.

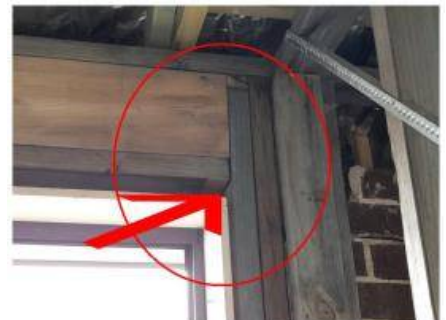
Recommend a longer lintel be installed and a stud placed under it for correct support of roof frame. This area would be classed as a major defect.

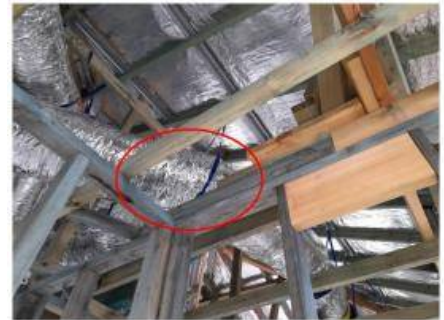
Ceiling trimming are missing and are required to adequately support the ceiling lining.

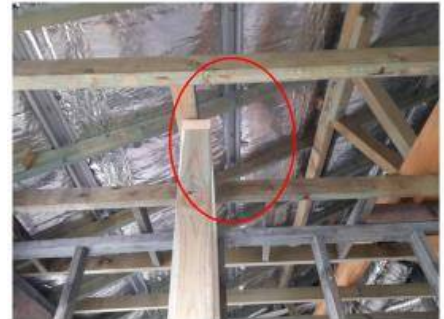
Ceiling trimming are missing and are required to adequately support the ceiling lining.

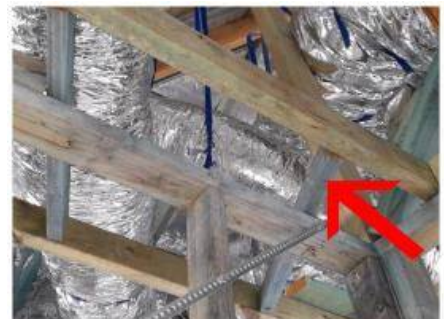
Recommend trimmers be cut to size and placed perpendicularly between joists.

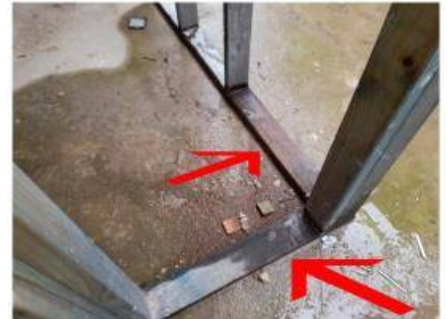
Poor or limited fixings were noted. Additional or replacement of fixings will be required to the wall plate to prevent movement.

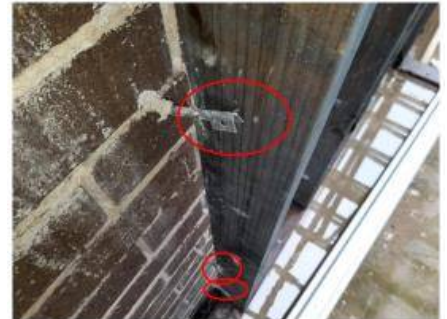
Brick ties are missing fixings and should be installed.

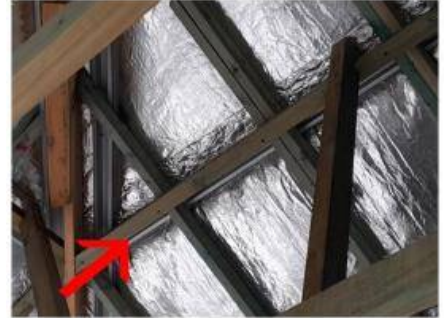
Recommend extra support installed below purlin to main bedroom.

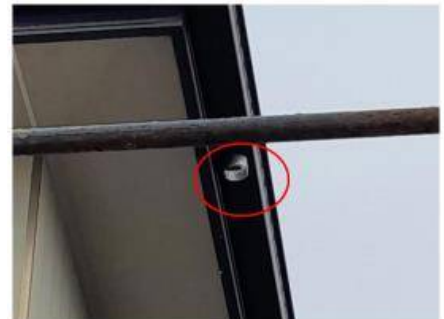
Recommend that temporary downpipes be installed.

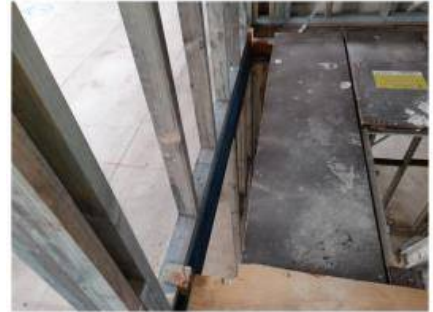
Recommend temporary rail be installed to scaffolding over stairwell to improve safety.
