Visual Property Inspection Report

Complies with Australian Standard AS 4349.1-2007 & 4349.3

4 Purchase Road, Perth WA 8000

VISUAL BUILDING INSPECTION REPORT

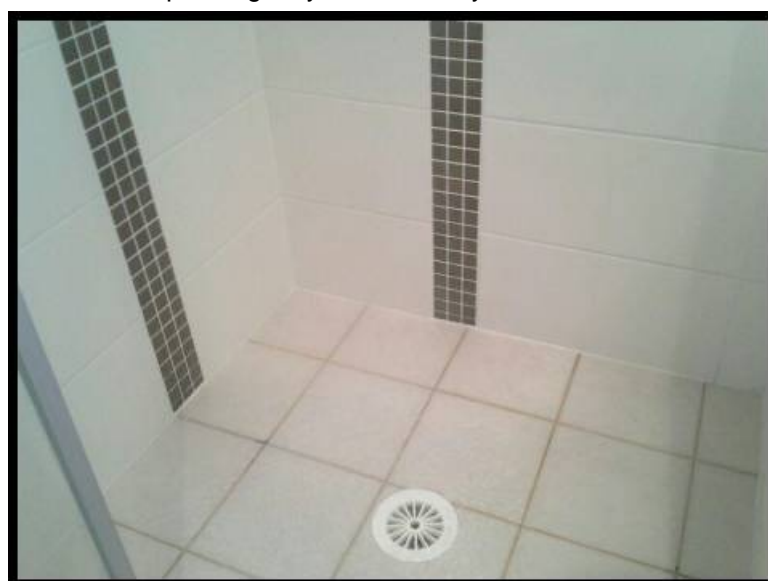
Room Location: Level one. Adjacent to hall.

Shower/Bath Condition: The shower recess was tested and there was no visible water penetration to surrounding areas. **IMPORTANT NOTE:** This test may not reveal water leaks until the shower is put into constant use and surrounding areas monitored over a period of time. Silicone sealant has been applied to the interface of the floor and walls in the shower recess in an apparent attempt to prevent water penetration to surrounding areas. This method of repair can only be considered to be temporary. glkhgkuglkugbkjkbk.b Test Shower ,hvkgljv.vljgcv.dchb.sbafeajbf.bfvebvbfvfeb Further waterproofing may be necessary.
