Visual Property Inspection Report

Complies with Australian Standard AS 4349.1-2007 & AS 4349.3-2010

5 Simple Place, Pleasantville

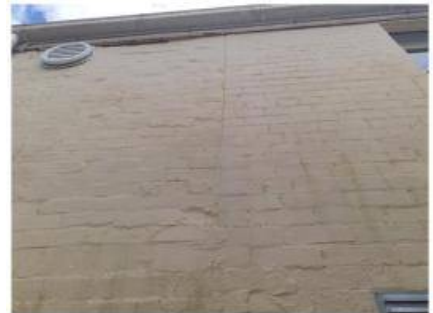
Cracks are evident to masonry. Visible cracking appears minor. Periodic maintenance may be required. Please refer to section of this report - CRACKING OF BUILDING ELEMENTS for additional details.

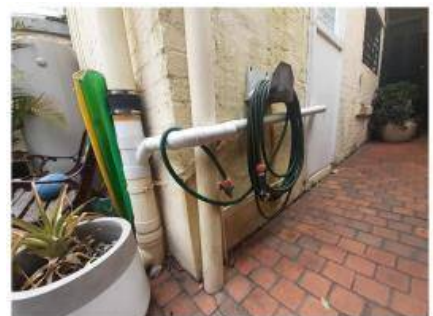
Vents and or weep holes are not present to the base of brick walls. The absence of vents and or weep holes can lead to ventilation and dampness problems. Recommend brick vents and or weep holes be installed to comply with current Standards.

Estimated cost from: \$1200.

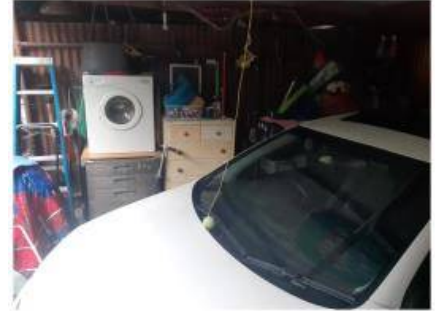
Stored items restricted inspection to the interior. These goods must be removed to enable a more complete report to be submitted. A vehicle is located in the area restricting inspection below, above and around the vehicle.

Defects and or damage requiring rectification may not be apparent to the inspector due to restriction. If restrictions are noted we **STRONGLY** recommend access be gained to enable a full inspection of the area.

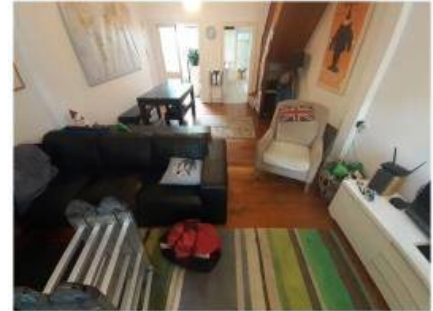
Both floorcoverings and furnishings were present and restricted inspection within this area. Due to the method of construction or other obstructions there was no access or limited access under the stairs.

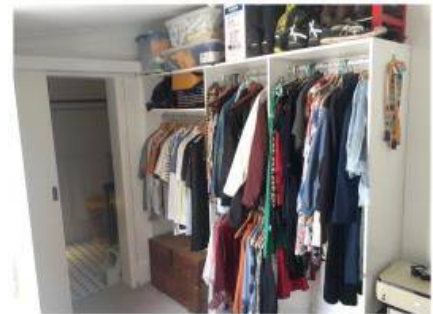
A significant amount of stored goods were present to the area(s) listed below which restricted the inspection. Stored items should be removed to allow a more complete inspection to be carried out. Access was limited in the following locations and or areas: Various areas. Wardrobes. Kitchen cupboards. Storage cupboard. Garage.

Defects and or damage requiring rectification may not be apparent to the inspector due to restriction. If restrictions are noted we **STRONGLY** recommend access be gained to enable a full inspection of the area.

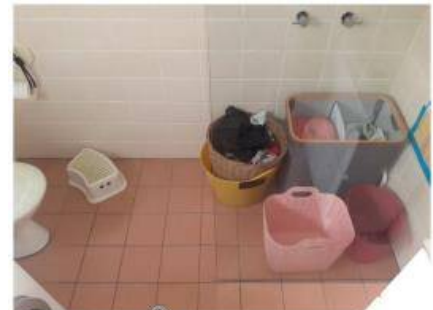
The shower recess was not tested as there is no hob to contain the water during testing. Accordingly, no report or opinion on this area is offered.

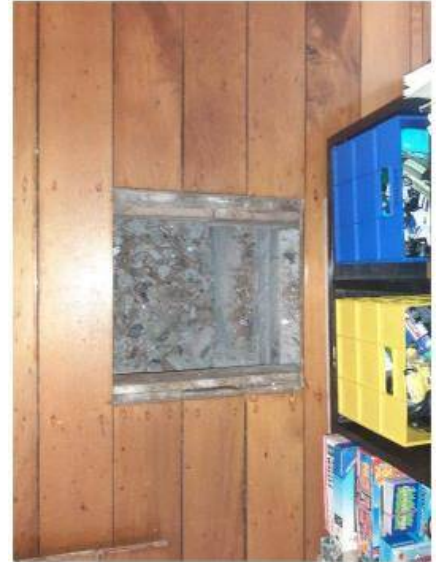
Some areas of the building are a concrete slab on ground construction and to these areas there is no accessible void for inspection. The entry point is too small to allow body access and accordingly no report on this area is submitted. Areas of the sub floor are too small/low to allow body access and accordingly no report on these area is submitted.

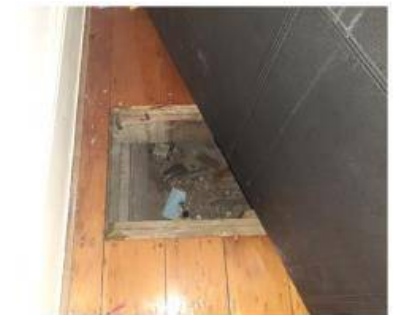
Inspection was restricted in or below the following locations and or areas: All internal areas.

Damage and or defects may be present and not detected in areas where inspection was limited, obstructed or access was not gained. If restrictions are noted we **STRONGLY** recommend that access be gained to all inaccessible areas.

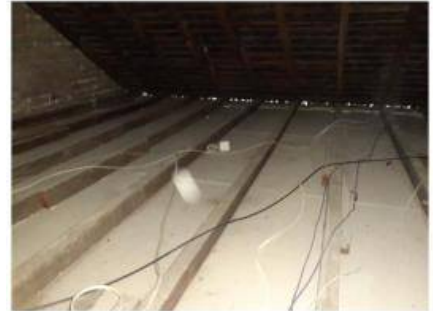
Inspection of framing within the roof cavity was significantly restricted by a heavy build up of dust. This prevents close inspection in detail of many roof timbers. Recommend the roof void be vacuumed to expose roof members for inspection. Inspection was restricted above the following locations and or areas: All internal areas.

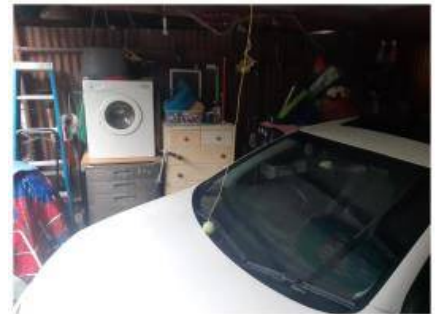
Stored items restricted inspection to the interior. These goods must be removed to enable a more complete report to be submitted. A vehicle is located in the area restricting inspection below, above and around the vehicle.

Active termites or other timber damaging pests may be present and not detected in areas where inspection was limited, obstructed or access was not gained. Recommend access be gained.

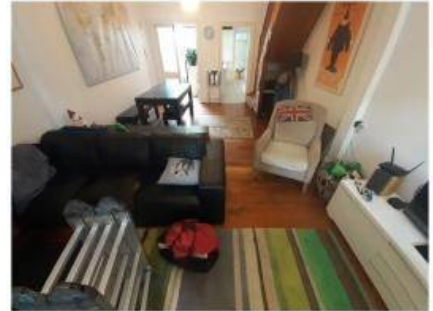
Both floorcoverings and furnishings were present and restricted inspection within this area. Due to the method of construction or other obstructions there was no access or limited access under the stairs.

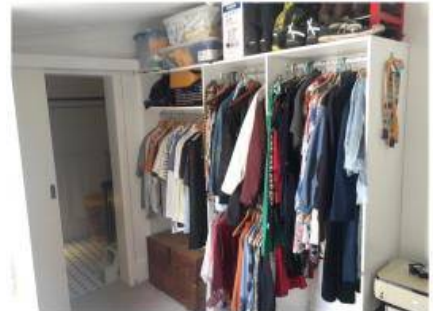
A significant amount of stored goods were present to the area(s) listed below which restricted the inspection. Stored items should be removed to allow a more complete inspection to be carried out. Access was limited in the following locations and or areas: Various areas. Wardrobes. Kitchen cupboards. Storage cupboard. Garage.

Active termites or other timber damaging pests may be present and not detected in areas where inspection was limited, obstructed or access was not gained.

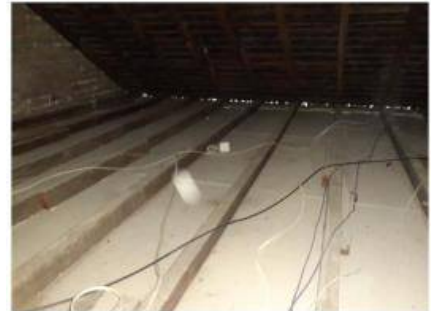
Inspection of framing within the roof cavity was significantly restricted by a heavy build up of dust. This prevents close inspection in detail of many roof timbers. Recommend the roof void be vacuumed to expose roof members for inspection. Inspection was restricted above the following locations and or areas: All internal areas.
