## Visual 90 Day Maintenance Property Inspection Report

Complies with Australian Standard AS 4349.1-2007

123 Nice Avenue, Smilington

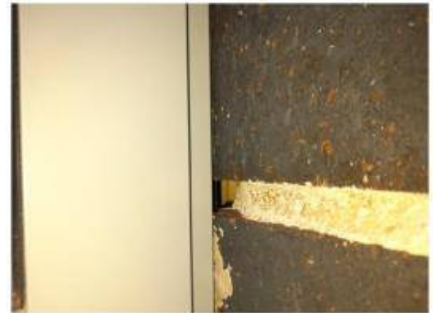
Storm moulds are not present and need to be fitted to ensure water does not penetrate wall cavity. Rectification is required.

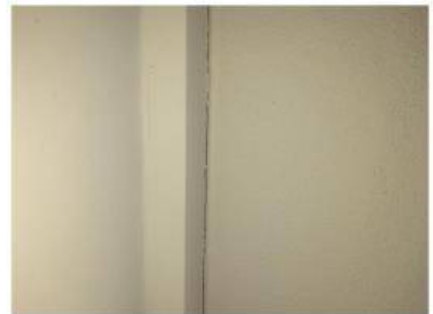
Gap filler is required to some sections of woodwork. Rectification will be required.

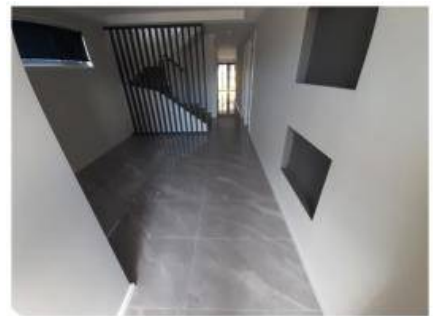
Minor paint touch ups are required.

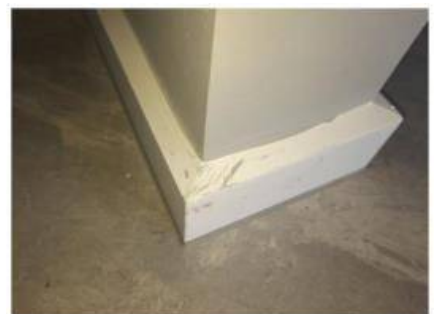
Minor paint touch ups are required.

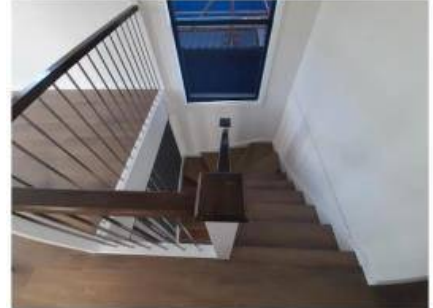
Defective or poor surfaces were noted to ceiling materials.  
Rectification will be required.

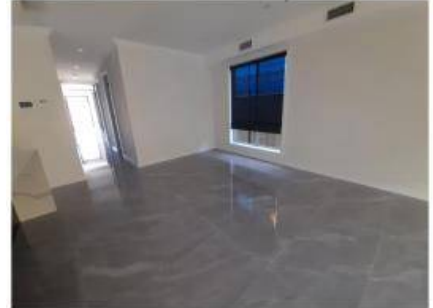
Minor paint touch ups are required.

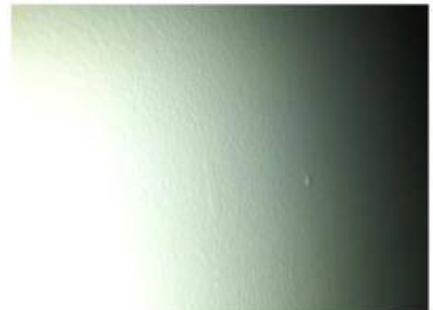
Defective or poor surfaces were noted to some sections of the wall materials. Rectification will be required.

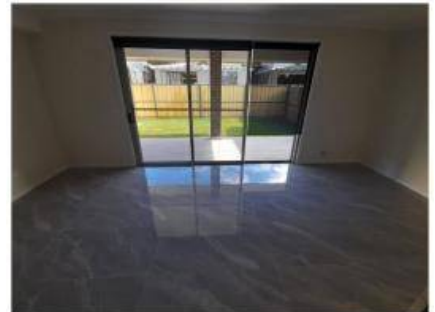
Defective or poor surfaces were noted to some sections of the wall materials. Rectification will be required.

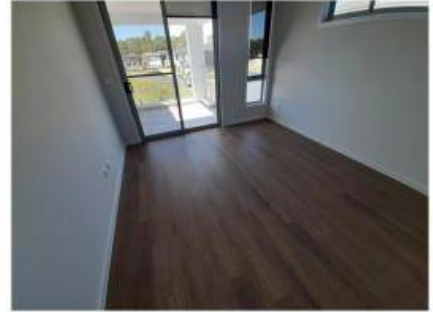
Defective or poor surfaces were noted to ceiling materials.  
Rectification will be required.

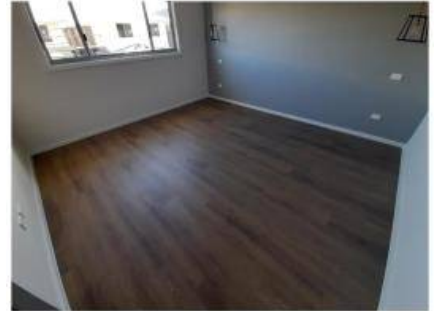
Defective or poor surfaces were noted to ceiling materials.  
Rectification will be required.

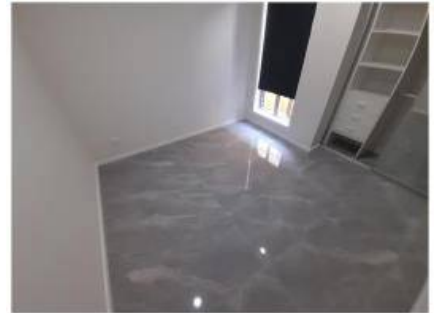
Minor paint touch ups are required.

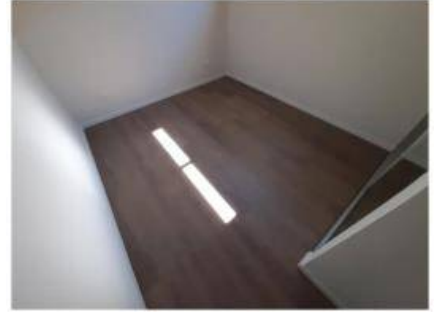
Defective or poor surfaces were noted to ceiling materials. Rectification will be required.

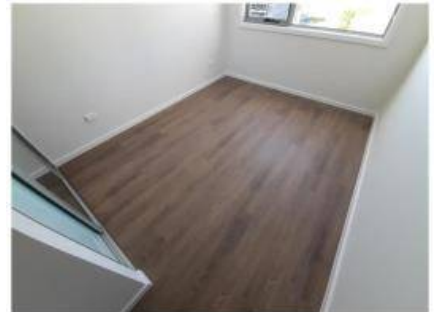
Defective or poor surfaces were noted to ceiling materials.  
Rectification will be required.

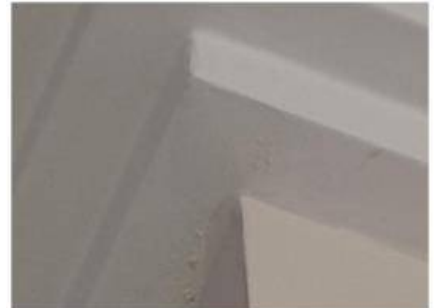
Defective or poor surfaces were noted to some sections of the  
wall materials. Rectification will be required.

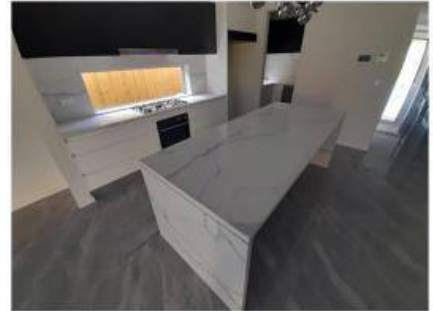
Defective or poor surfaces were noted to ceiling materials. Rectification will be required.

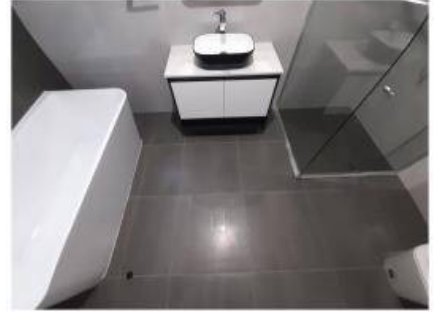
Defective or poor surfaces were noted to ceiling materials. Rectification will be required.

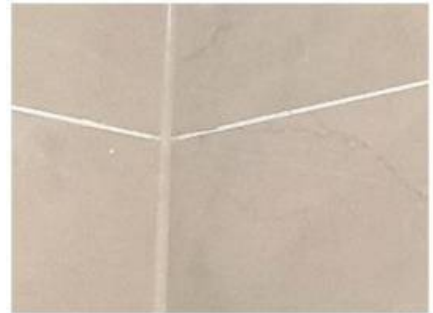
Grouting requires completing to the tiled areas. Rectification will be required.

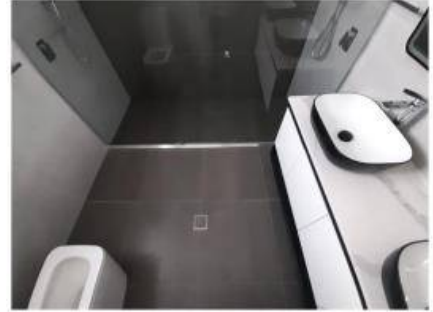
Defective or poor surfaces were noted to ceiling materials.  
Rectification will be required.

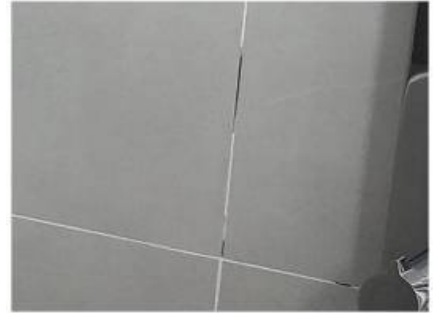
Grouting requires completing to the tiled areas. Rectification will be required.

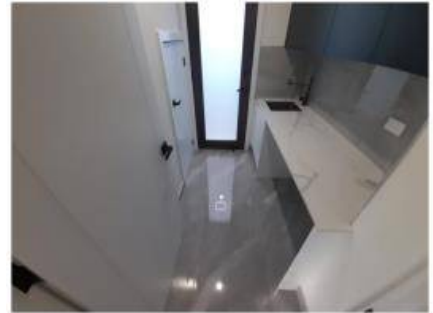
Minor paint touch ups are required.
